PORT OF CORPUS CHRISTI AUTHORITY

OIL DOCK 15  
SOUNDINGS  
AN EXHIBIT OF A  
BATHYMETRIC SURVEY  
LOCATED IN  
CORPUS CHRISTI, TEXAS

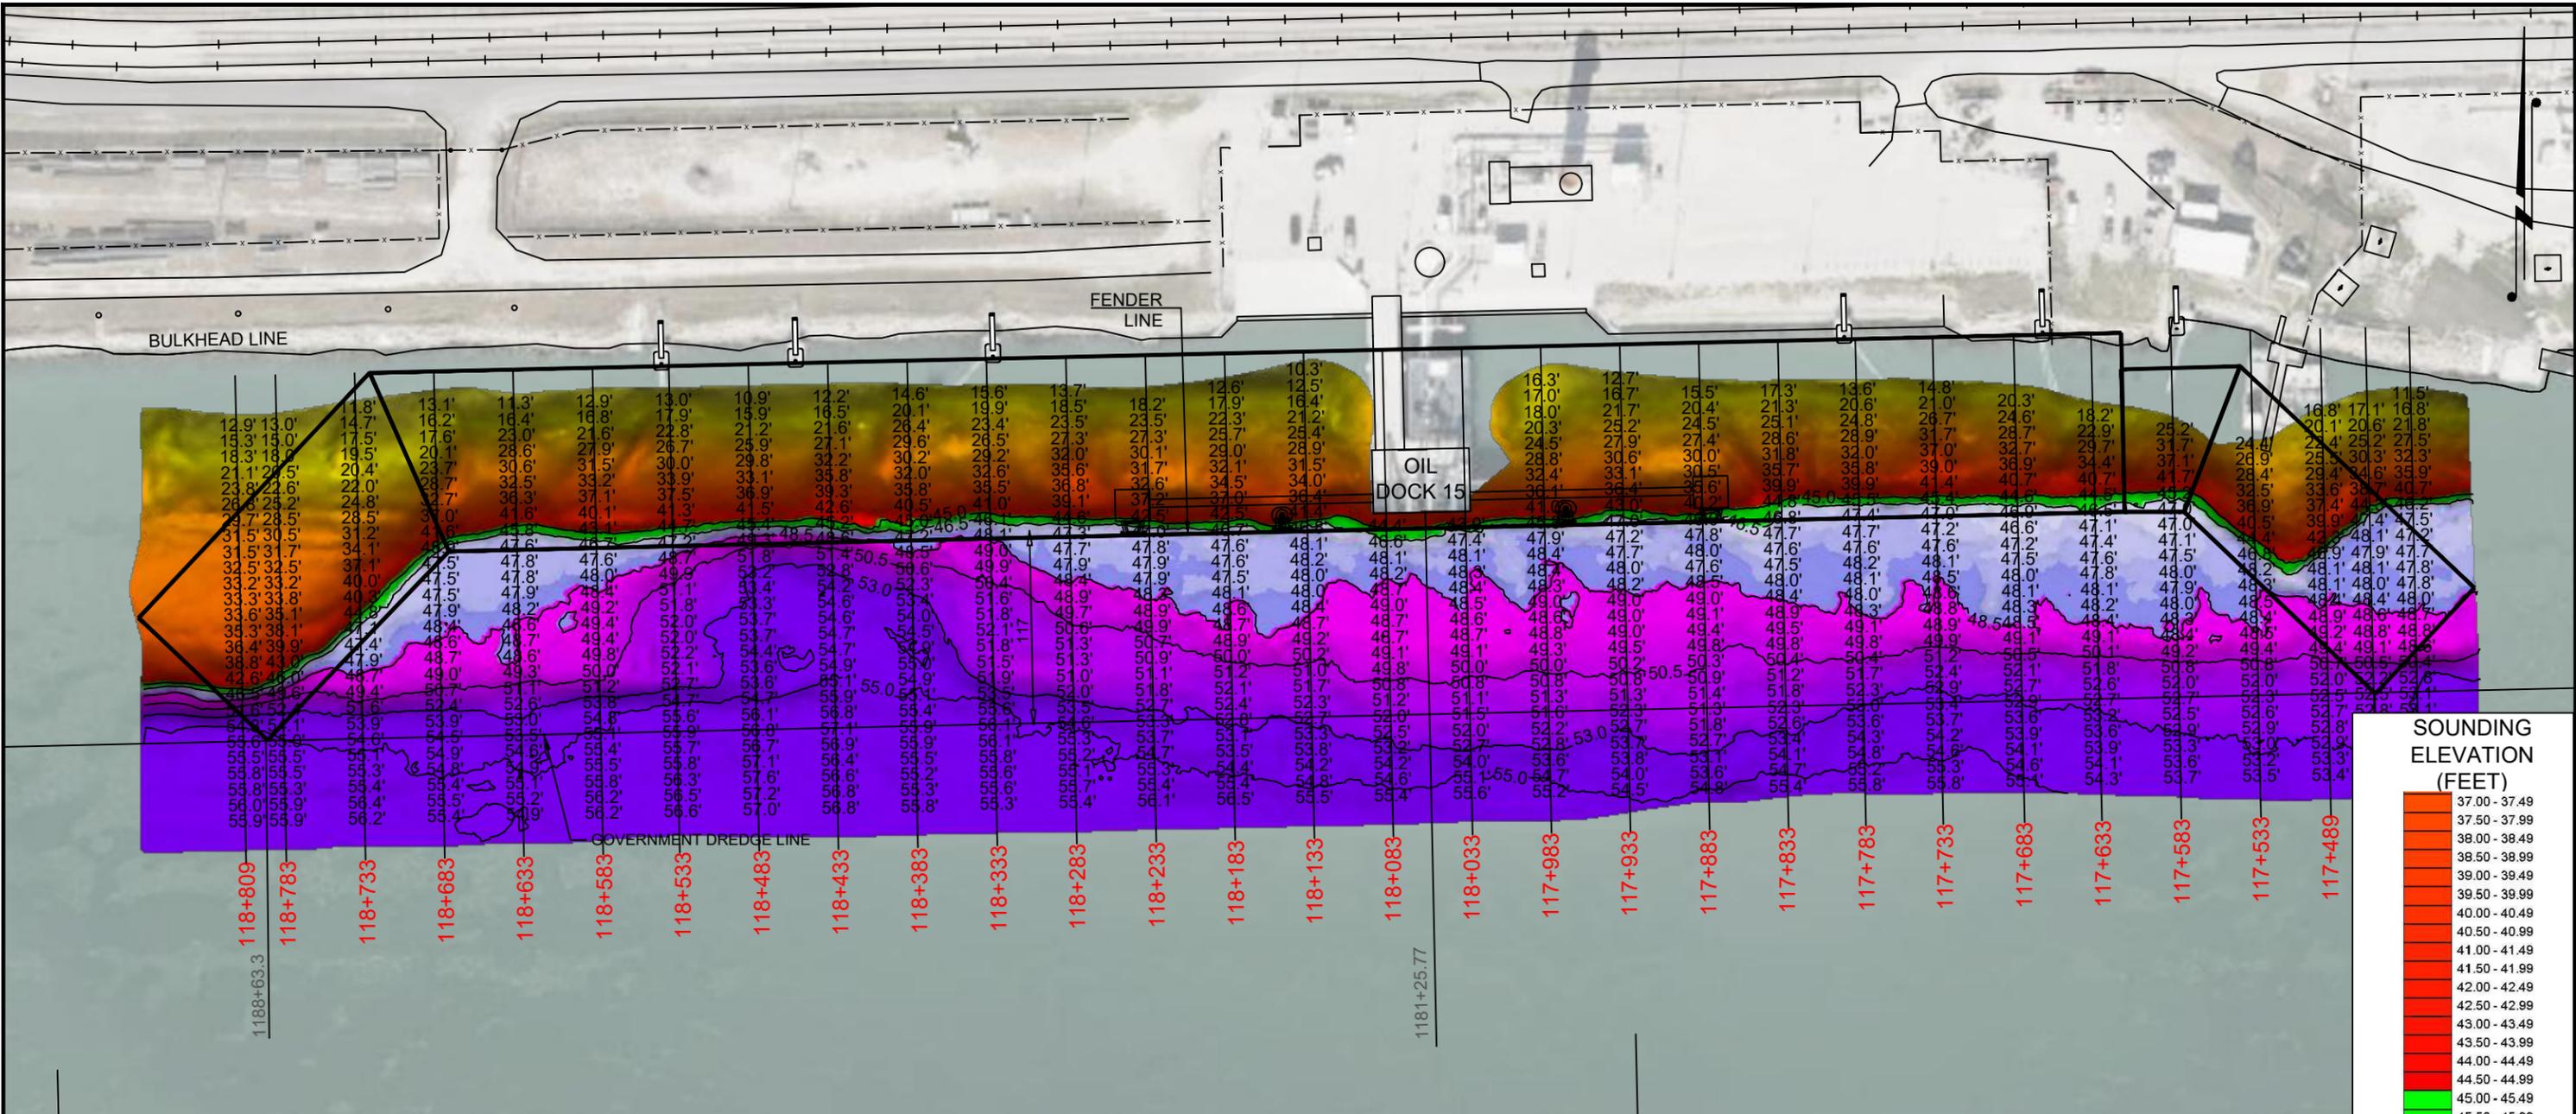
- NOTES:
- SOUNDINGS WERE RECORDED BY T BAKER SMITH ON 29 JANUARY, 2026.
  - SEA FLOOR CONDITIONS ARE SUBJECT TO CHANGE.
  - THE PORT OF CORPUS CHRISTI ASSUMES NO LIABILITY FOR THE ACCURACY OF THIS INFORMATION. THE INFORMATION DEPICTED ON THIS MAP REPRESENTS THE RESULTS OF SURVEYS MADE ON THE DATE DEPICTED AND CAN ONLY BE CONSIDERED AS INDICATING THE GENERAL CONDITIONS AT THAT TIME. THESE CONDITIONS ARE SUBJECT TO RAPID CHANGE DUE TO SHOALING EVENTS.
  - ALL READINGS ARE BASED ON THE NATIONAL OCEANIC AND ATMOSPHERIC ADMINISTRATION (NOAA) MEAN LOWER LOW WATER (MLLW) DATUM, (O.O')
  - HORIZONTAL DATUM: NAD-83, STATE PLANE, TEXAS SOUTH ZONE, US FEET.
  - TO GET THE DEPTH OF WATER, ADD THE CURRENT TIDE LEVEL TO THE READINGS SHOWN. (SEE TIDE DATUM CHART).
