P:\Y-2024\2024_0287\DRAWINGS\Q1_2024_PCC DOCKS\OD 15\OIL DOCK_15_BATHY 4MARCH2024.DWG

PORT OF CORPUS CHRISTI AUTHORITY

OIL DOCK 15
SOUNDINGS
AN EXHIBIT OF A
BATHYMETRIC SURVEY
LOCATED IN
CORPUS CHRISTI, TEXAS

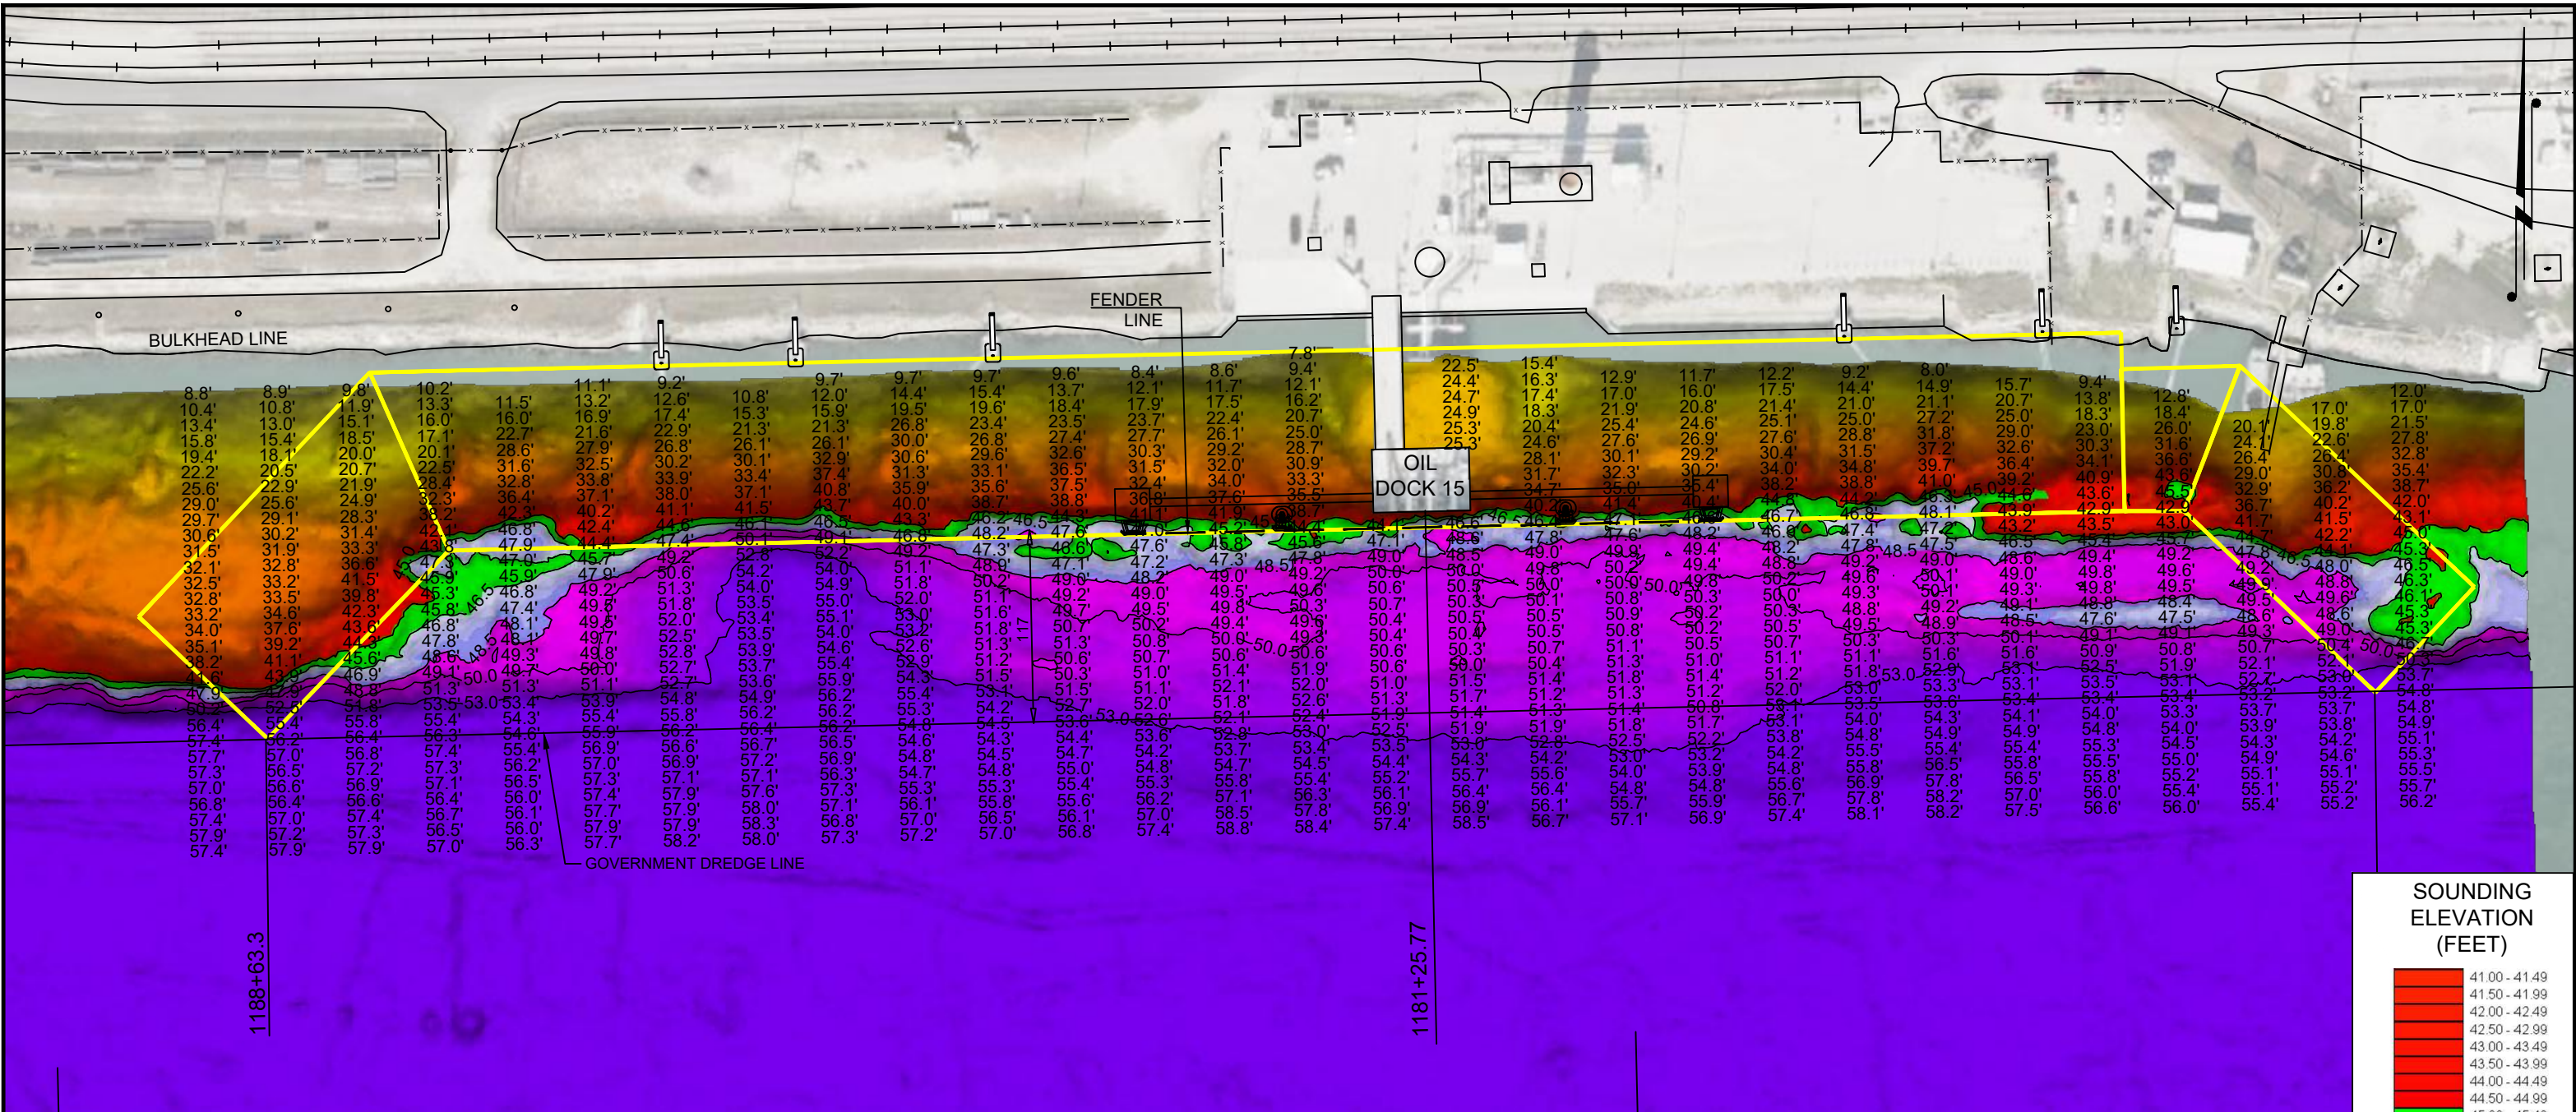
SOUNDING ELEVATION (FEET)

- NOTES:**
- SOUNDINGS WERE RECORDED BY T BAKER SMITH ON 4 MARCH, 2024. SEA FLOOR CONDITIONS ARE SUBJECT TO CHANGE.
 - THE PORT OF CORPUS CHRISTI ASSUMES NO LIABILITY FOR THE ACCURACY OF THIS INFORMATION. THE INFORMATION DEPICTED ON THIS MAP REPRESENTS THE RESULTS OF SURVEYS MADE ON THE DATE DEPICTED AND CAN ONLY BE CONSIDERED AS INDICATING THE GENERAL CONDITIONS AT THAT TIME. THESE CONDITIONS ARE SUBJECT TO RAPID CHANGE DUE TO SHOALING EVENTS.
 - ALL READINGS ARE BASED ON THE NATIONAL OCEANIC AND ATMOSPHERIC ADMINISTRATION (NOAA) MEAN LOWER LOW WATER (MLLW) DATUM, (O.O')
 - HORIZONTAL DATUM: NAD-83, STATE PLANE, TEXAS SOUTH ZONE, US FEET.
 - TO GET THE DEPTH OF WATER, ADD THE CURRENT TIDE LEVEL TO THE READINGS SHOWN. (SEE TIDE DATUM CHART).
