**PORT OF CORPUS CHRISTI AUTHORITY**

**OIL DOCK 15  
SOUNDINGS**  
AN EXHIBIT OF A  
BATHYMETRIC SURVEY  
LOCATED IN  
CORPUS CHRISTI, TEXAS

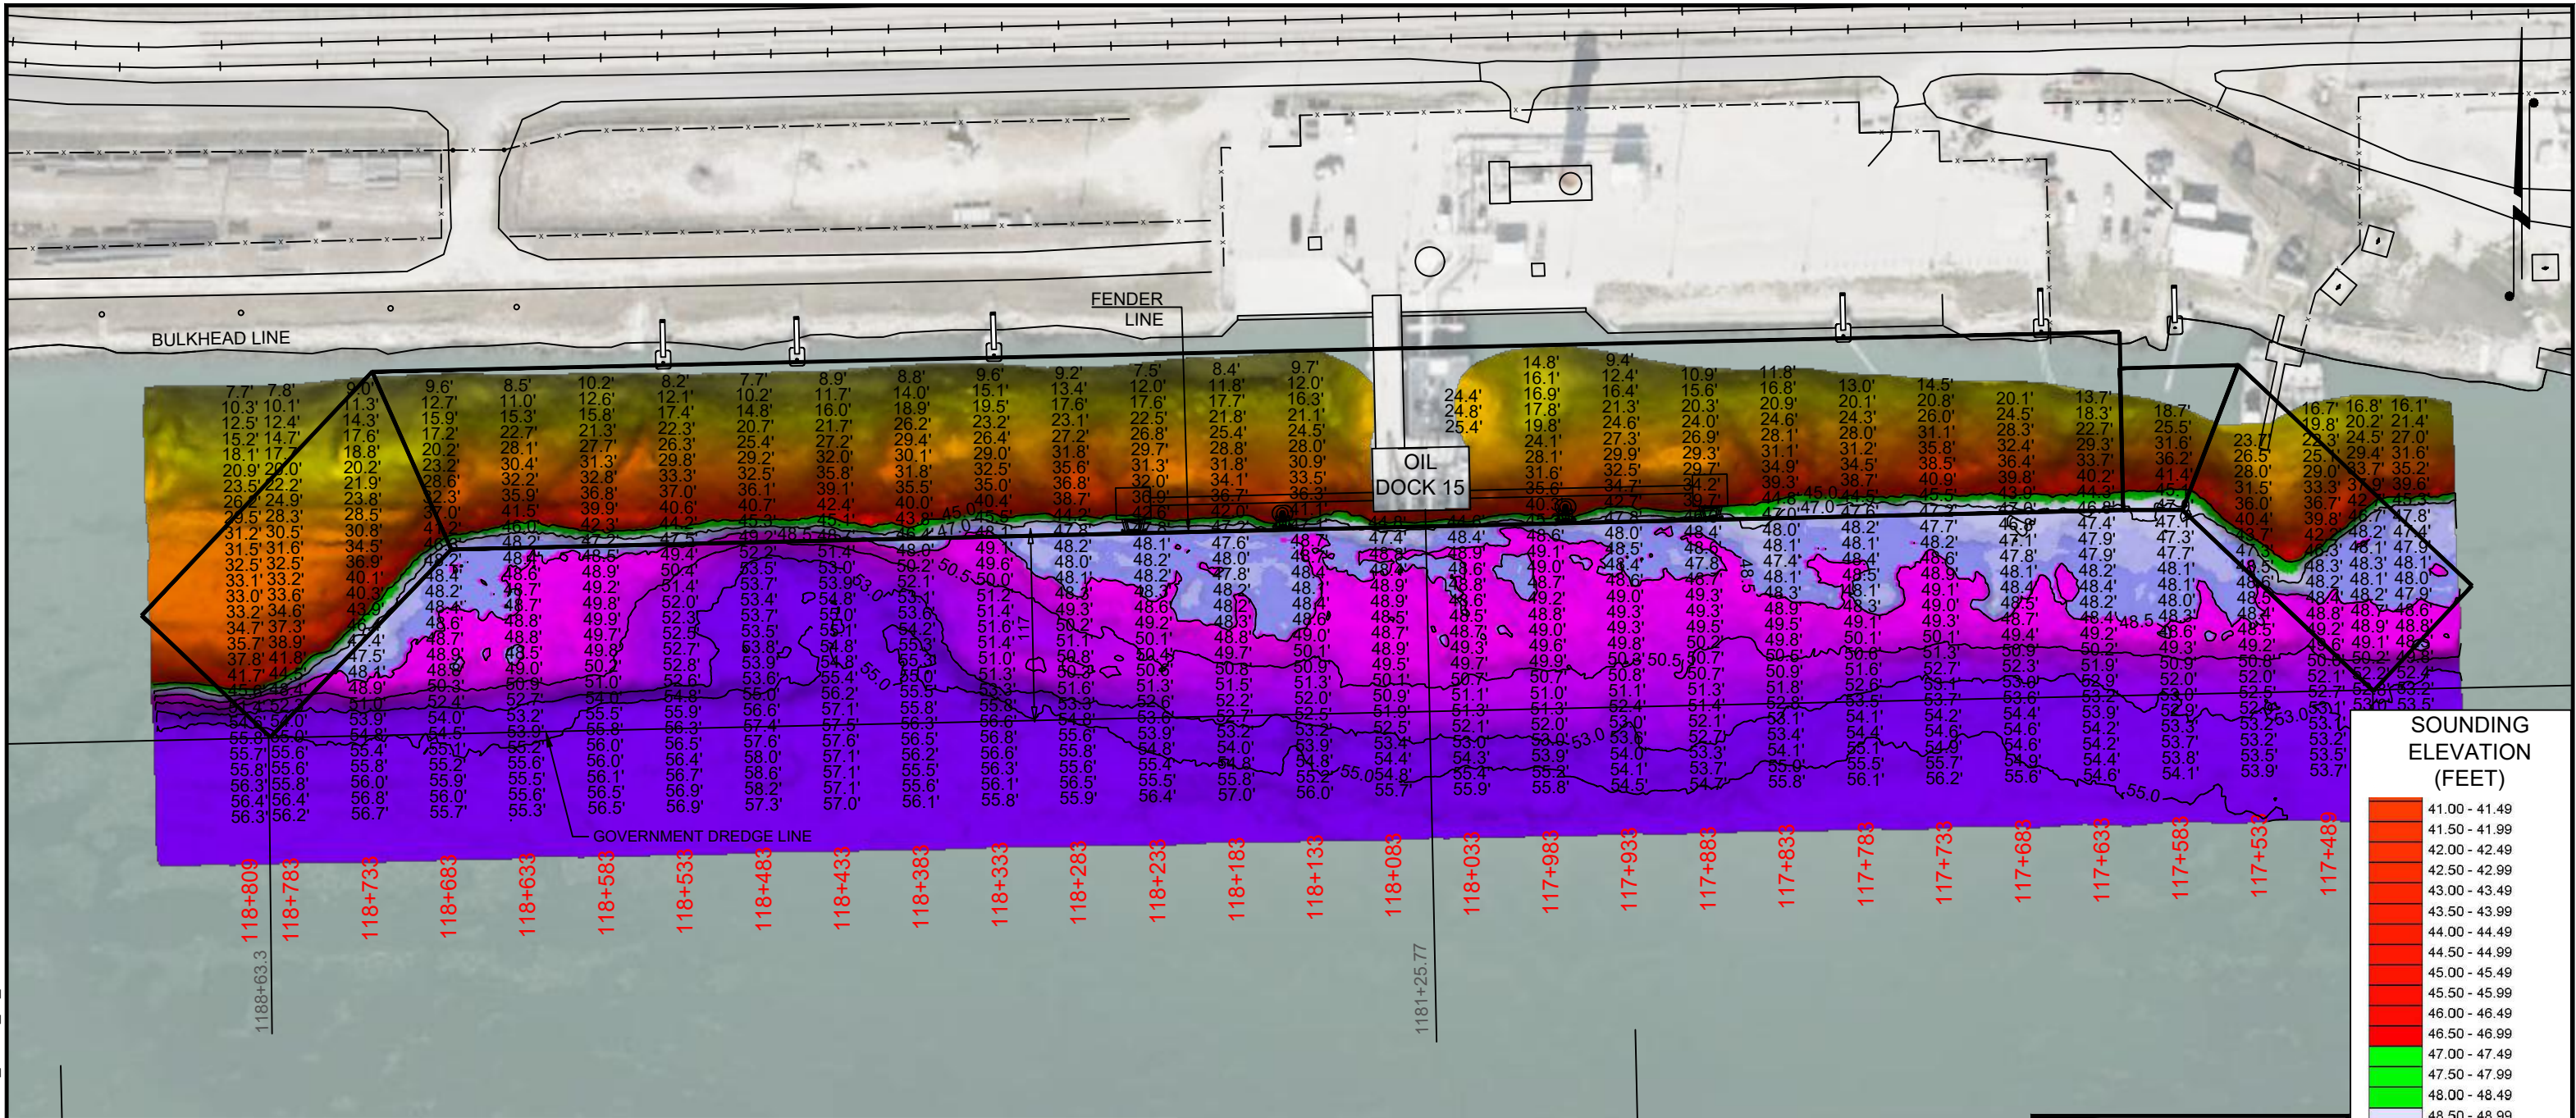
| DRAWING NAME: | OIL DOCK 15 BATHY 6AUG2025 | | |

- NOTES:**
- SOUNDINGS WERE RECORDED BY T BAKER SMITH ON 6 AUGUST, 2025.
  - SEA FLOOR CONDITIONS ARE SUBJECT TO CHANGE.
  - THE PORT OF CORPUS CHRISTI ASSUMES NO LIABILITY FOR THE ACCURACY OF THIS INFORMATION. THE INFORMATION DEPICTED ON THIS MAP REPRESENTS THE RESULTS OF SURVEYS MADE ON THE DATE DEPICTED AND CAN ONLY BE CONSIDERED AS INDICATING THE GENERAL CONDITIONS AT THAT TIME. THESE CONDITIONS ARE SUBJECT TO RAPID CHANGE DUE TO SHOALING EVENTS.
  - ALL READINGS ARE BASED ON THE NATIONAL OCEANIC AND ATMOSPHERIC ADMINISTRATION (NOAA) MEAN LOWER LOW WATER (MLLW) DATUM, (O.O')
  - HORIZONTAL DATUM: NAD-83, STATE PLANE, TEXAS SOUTH ZONE, US FEET.
  - TO GET THE DEPTH OF WATER, ADD THE CURRENT TIDE LEVEL TO THE READINGS SHOWN. (SEE TIDE DATUM CHART).
