DRAWN BY:	CDW	APPROVED BY:	AWK
DATE:	11/24/2025	JOB NO:	2025.0225
DRAWING NAME: OIL DOCK 2 14NOV2025			
PROJECTION: TEXAS STATE PLANE SOUTH ZONE GEO. DATUM: NAD83 (2011) VERT. DATUM: MLLW GRID UNITS: US SURVEY FEET			
SHEET NO:	1	OF	1

PORT OF CORPUS CHRISTI AUTHORITY

OIL DOCK 2
SOUNDINGS
AN EXHIBIT OF A
BATHYMETRIC SURVEY
LOCATED IN
CORPUS CHRISTI, TEXAS

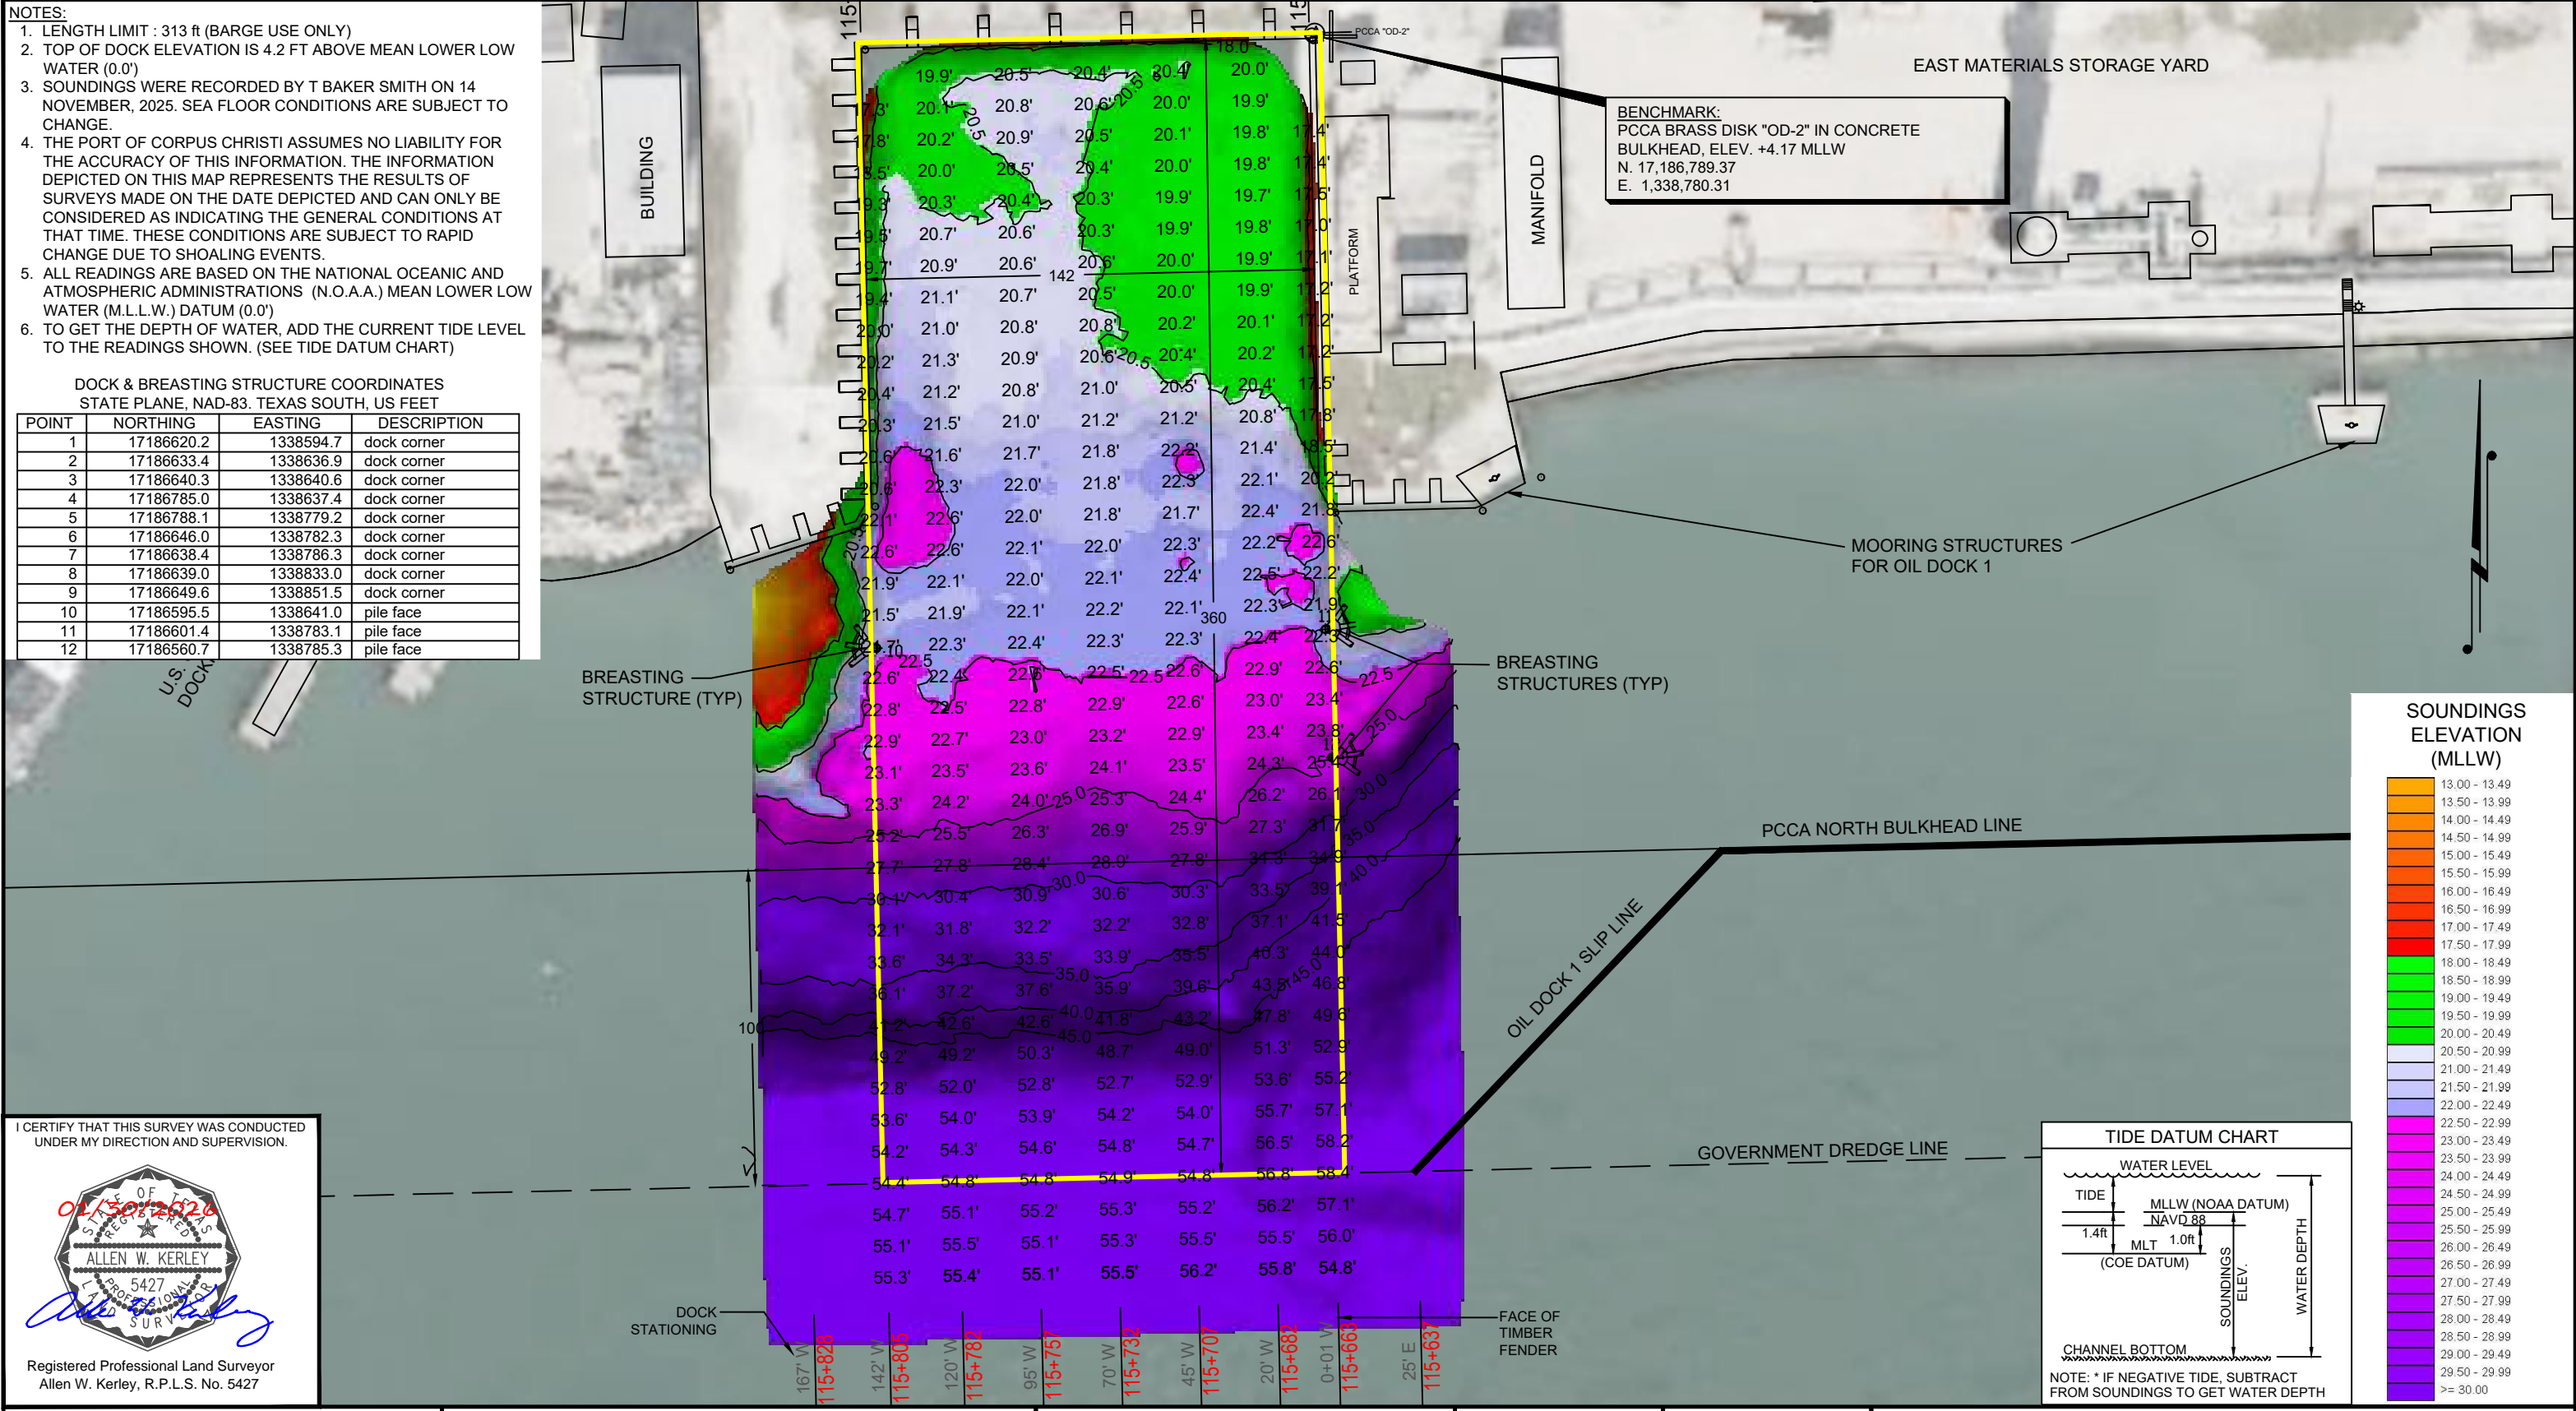
1. LENGTH LIMIT : 313 ft (BARGE USE ONLY)
2. TOP OF DOCK ELEVATION IS 4.2 FT ABOVE MEAN LOWER LOW WATER (0.0')
3. SOUNDINGS WERE RECORDED BY T BAKER SMITH ON 14 NOVEMBER, 2025. SEA FLOOR CONDITIONS ARE SUBJECT TO CHANGE.
4. THE PORT OF CORPUS CHRISTI ASSUMES NO LIABILITY FOR THE ACCURACY OF THIS INFORMATION. THE INFORMATION DEPICTED ON THIS MAP REPRESENTS THE RESULTS OF SURVEYS MADE ON THE DATE DEPICTED AND CAN ONLY BE CONSIDERED AS INDICATING THE GENERAL CONDITIONS AT THAT TIME. THESE CONDITIONS ARE SUBJECT TO RAPID CHANGE DUE TO SHOALING EVENTS.
5. ALL READINGS ARE BASED ON THE NATIONAL OCEANIC AND ATMOSPHERIC ADMINISTRATIONS (N.O.A.A.) MEAN LOWER LOW WATER (M.L.L.W.) DATUM (0.0')
6. TO GET THE DEPTH OF WATER, ADD THE CURRENT TIDE LEVEL TO THE READINGS SHOWN. (SEE TIDE DATUM CHART)

POINT	NORTHING	EASTING	DESCRIPTION
1	17186620.2	1338594.7	dock corner
2	17186633.4	1338636.9	dock corner
3	17186640.3	1338640.6	dock corner
4	17186785.0	1338637.4	dock corner
5	17186788.1	1338779.2	dock corner
6	17186646.0	1338782.3	dock corner
7	17186638.4	1338786.3	dock corner
8	17186639.0	1338833.0	dock corner
9	17186649.6	1338851.5	dock corner
10	17186595.5	1338641.0	pile face
11	17186601.4	1338783.1	pile face
12	17186560.7	1338785.3	pile face
