SHEET NO: 1 OF 2

PORT OF CORPUS CHRISTI AUTHORITY

OIL DOCK 3  
SOUNDINGS  
AN EXHIBIT OF A  
BATHYMETRIC SURVEY  
LOCATED IN  
CORPUS CHRISTI, TEXAS

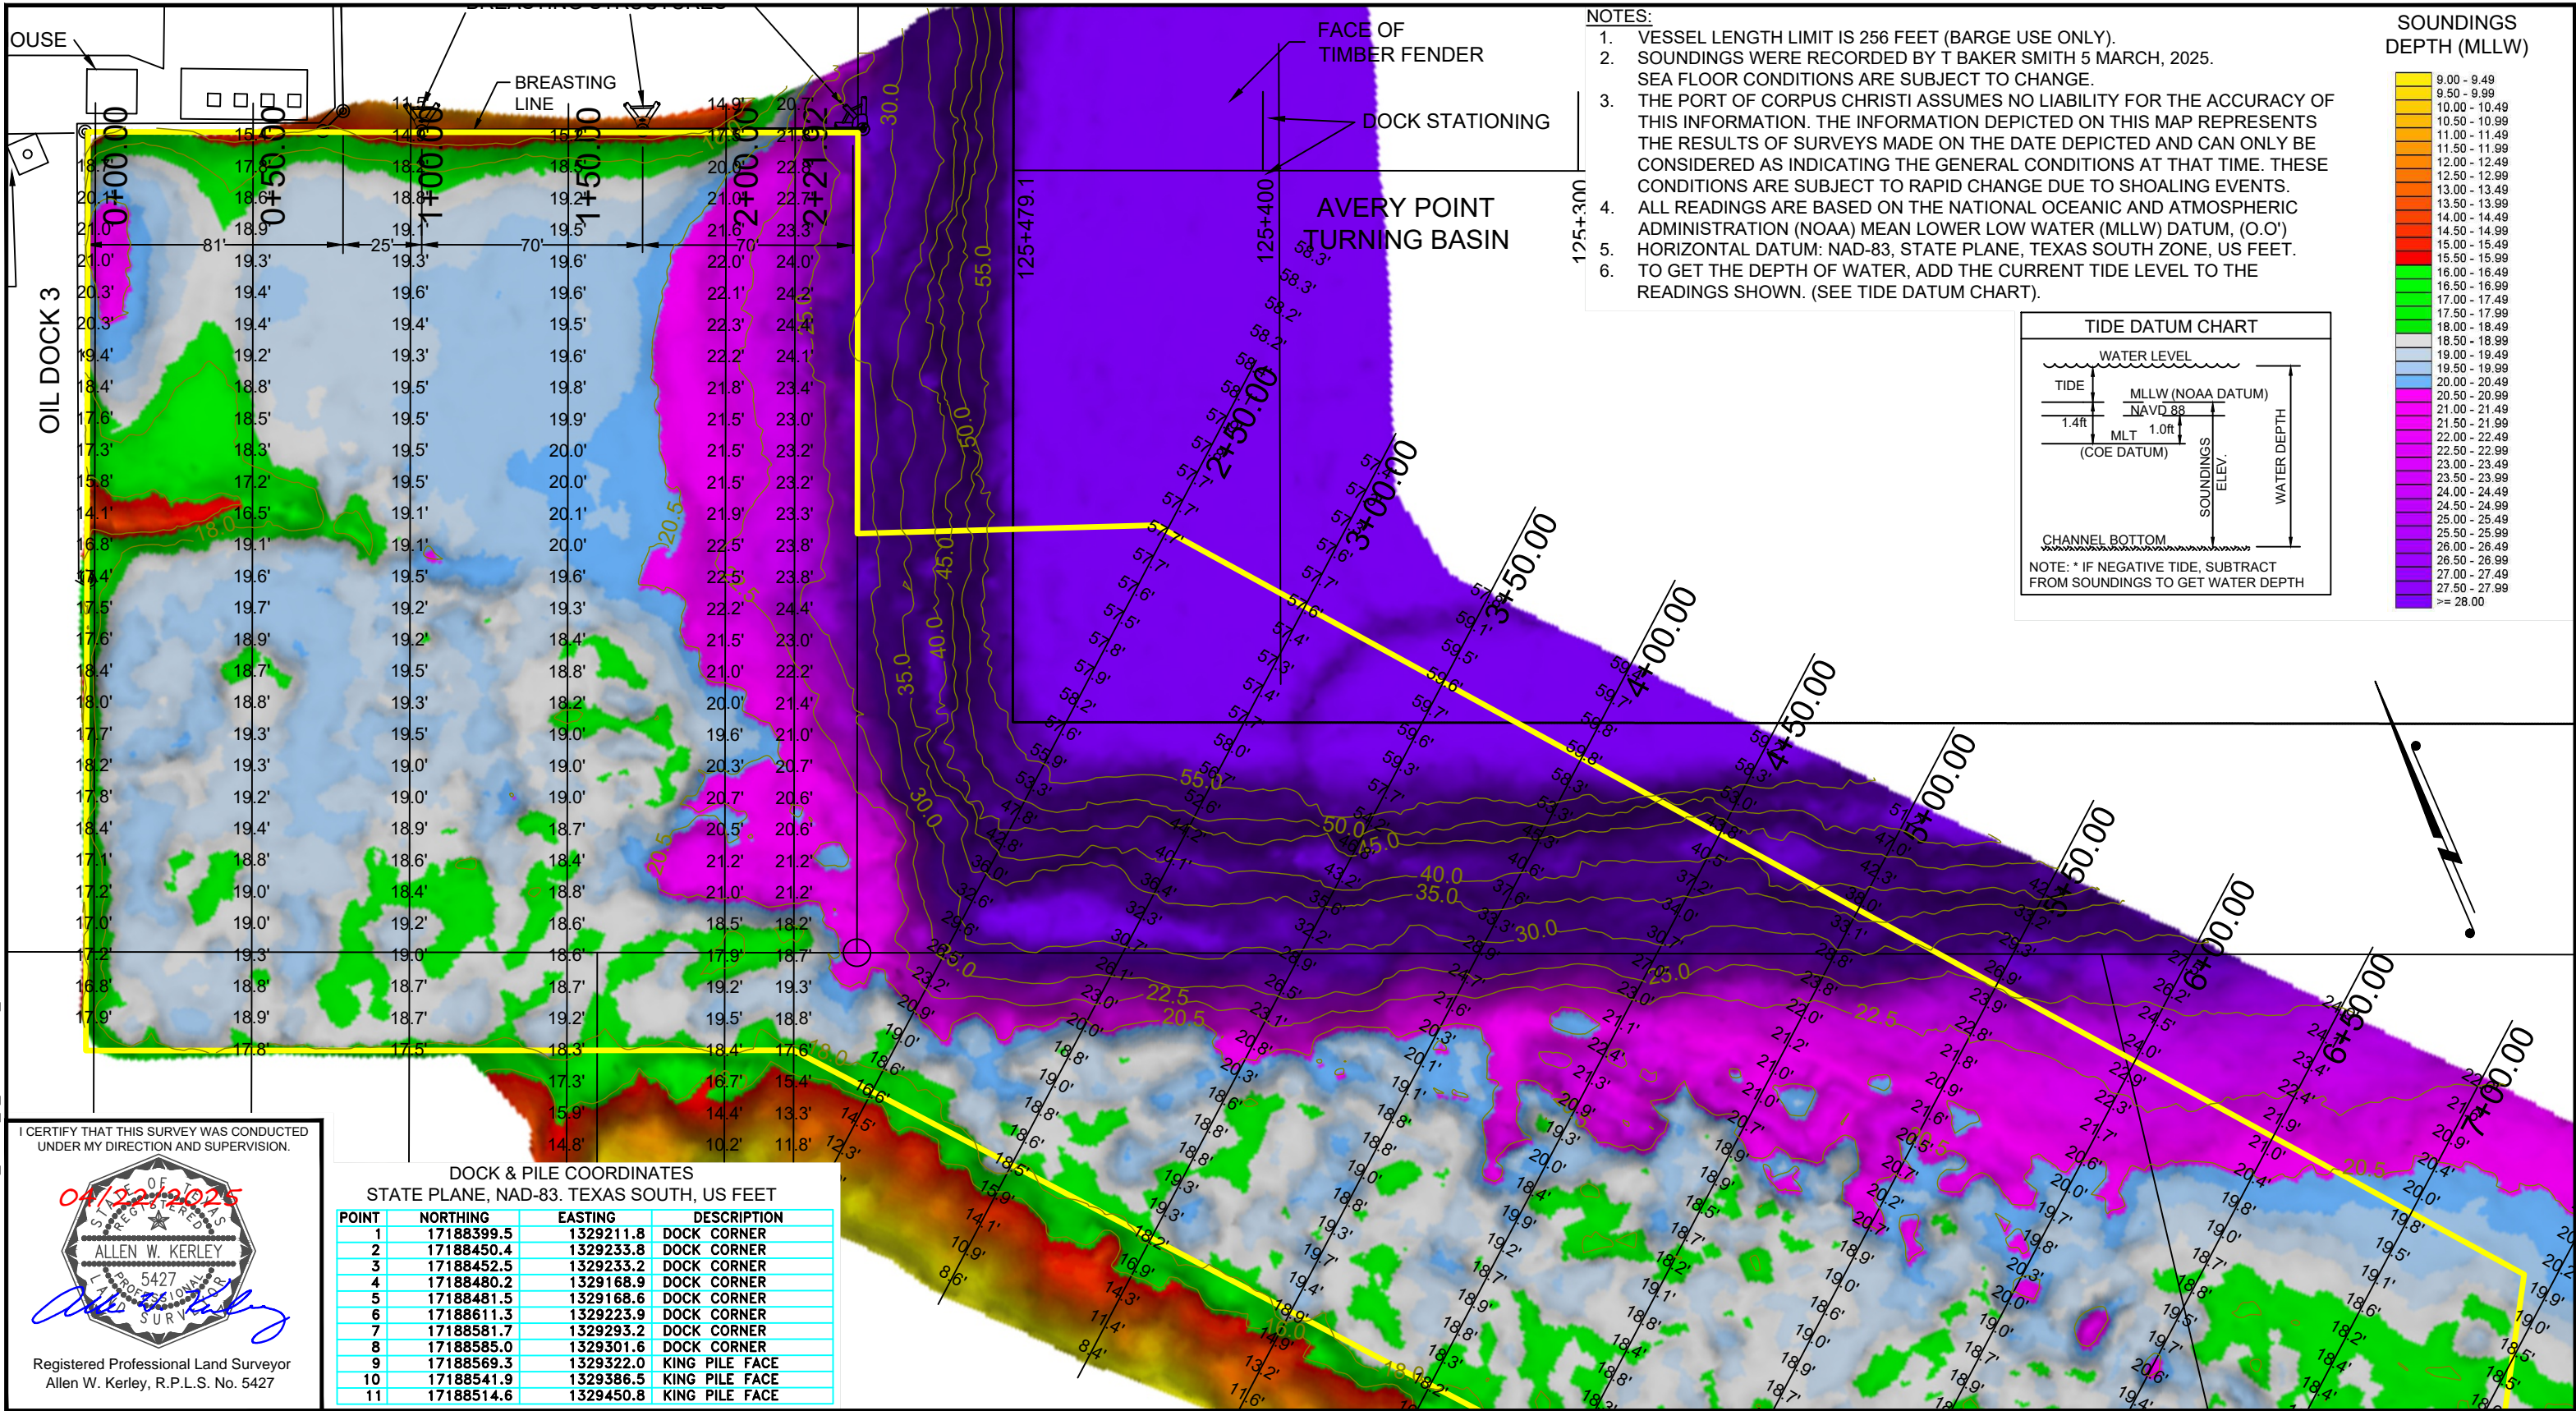
1. VESSEL LENGTH LIMIT IS 256 FEET (BARGE USE ONLY).
2. SOUNDINGS WERE RECORDED BY T BAKER SMITH 5 MARCH, 2025. SEA FLOOR CONDITIONS ARE SUBJECT TO CHANGE.
3. THE PORT OF CORPUS CHRISTI ASSUMES NO LIABILITY FOR THE ACCURACY OF THIS INFORMATION. THE INFORMATION DEPICTED ON THIS MAP REPRESENTS THE RESULTS OF SURVEYS MADE ON THE DATE DEPICTED AND CAN ONLY BE CONSIDERED AS INDICATING THE GENERAL CONDITIONS AT THAT TIME. THESE CONDITIONS ARE SUBJECT TO RAPID CHANGE DUE TO SHOALING EVENTS.
4. ALL READINGS ARE BASED ON THE NATIONAL OCEANIC AND ATMOSPHERIC ADMINISTRATION (NOAA) MEAN LOWER LOW WATER (MLLW) DATUM, (O.O')
5. HORIZONTAL DATUM: NAD-83, STATE PLANE, TEXAS SOUTH ZONE, US FEET.
6. TO GET THE DEPTH OF WATER, ADD THE CURRENT TIDE LEVEL TO THE READINGS SHOWN. (SEE TIDE DATUM CHART).

SOUNDINGS DEPTH (MLLW)
