| <br><b>PORT CORPUS CHRISTI</b> | <br><b>T. BAKER SMITH</b><br>A CENTURY OF SOLUTIONS<br>3854 FM 1069<br>Aransas Pass, TX 78336<br>(361)334-5719 - tbsmith.com<br>TBPLS #10194575 | SCALE: 1" = 50' | DRAWN BY: CDW | APPROVED BY: AWK | <b>PORT OF CORPUS CHRISTI AUTHORITY</b><br><br><b>OIL DOCK 3</b><br>2026-Q2<br>AN EXHIBIT OF A<br>BATHYMETRIC SURVEY<br>LOCATED IN<br>CORPUS CHRISTI, TEXAS |

OIL DOCK 3  
2026-Q2  
AN EXHIBIT OF A  
BATHYMETRIC SURVEY  
LOCATED IN  
CORPUS CHRISTI, TEXAS

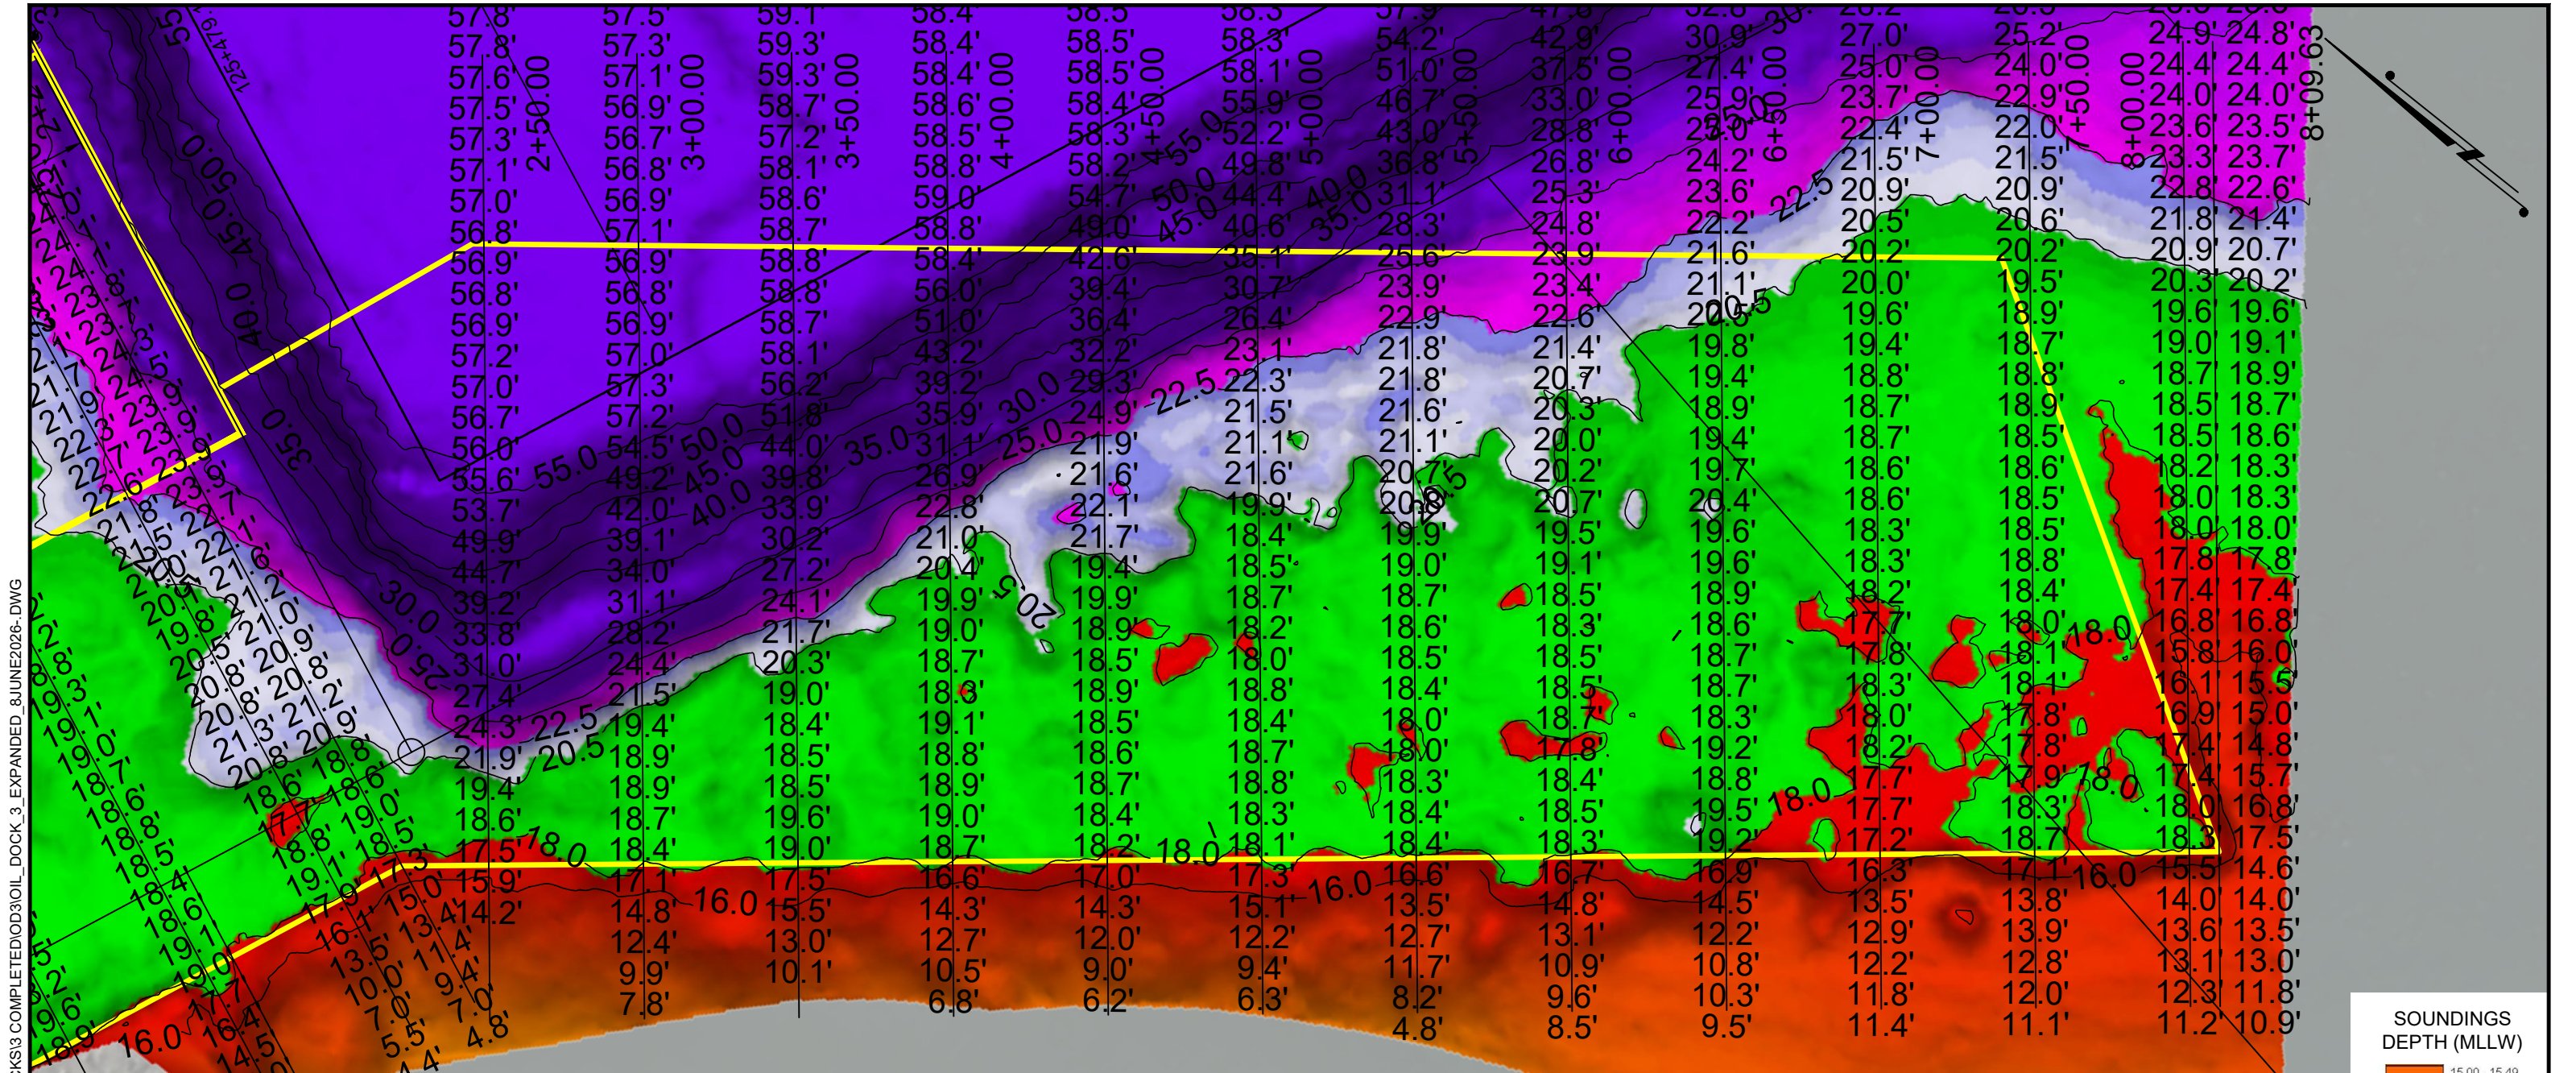
| SHEET NO: | 2 | OF | 2 |

- NOTES:
- VESSEL LENGTH LIMIT IS 256 FEET (BARGE USE ONLY).
  - SOUNDINGS WERE RECORDED BY T BAKER SMITH 8 JUNE, 2026. SEA FLOOR CONDITIONS ARE SUBJECT TO CHANGE.
  - THE PORT OF CORPUS CHRISTI ASSUMES NO LIABILITY FOR THE ACCURACY OF THIS INFORMATION. THE INFORMATION DEPICTED ON THIS MAP REPRESENTS THE RESULTS OF SURVEYS MADE ON THE DATE DEPICTED AND CAN ONLY BE CONSIDERED AS INDICATING THE GENERAL CONDITIONS AT THAT TIME. THESE CONDITIONS ARE SUBJECT TO RAPID CHANGE DUE TO SHOALING EVENTS.
  - ALL READINGS ARE BASED ON THE NATIONAL OCEANIC AND ATMOSPHERIC ADMINISTRATION (NOAA) MEAN LOWER LOW WATER (MLLW) DATUM, (O.O')
  - HORIZONTAL DATUM: NAD-83, STATE PLANE, TEXAS SOUTH ZONE, US FEET.
  - TO GET THE DEPTH OF WATER, ADD THE CURRENT TIDE LEVEL TO THE READINGS SHOWN. (SEE TIDE DATUM CHART).
