| DRAWING NAME: OIL DOCK 4 8JUN2023 | |

PORT OF CORPUS CHRISTI AUTHORITY

**OIL DOCK 4
 SOUNDINGS**
 AN EXHIBIT OF A
 BATHYMETRIC SURVEY
 LOCATED IN
 CORPUS CHRISTI, TEXAS

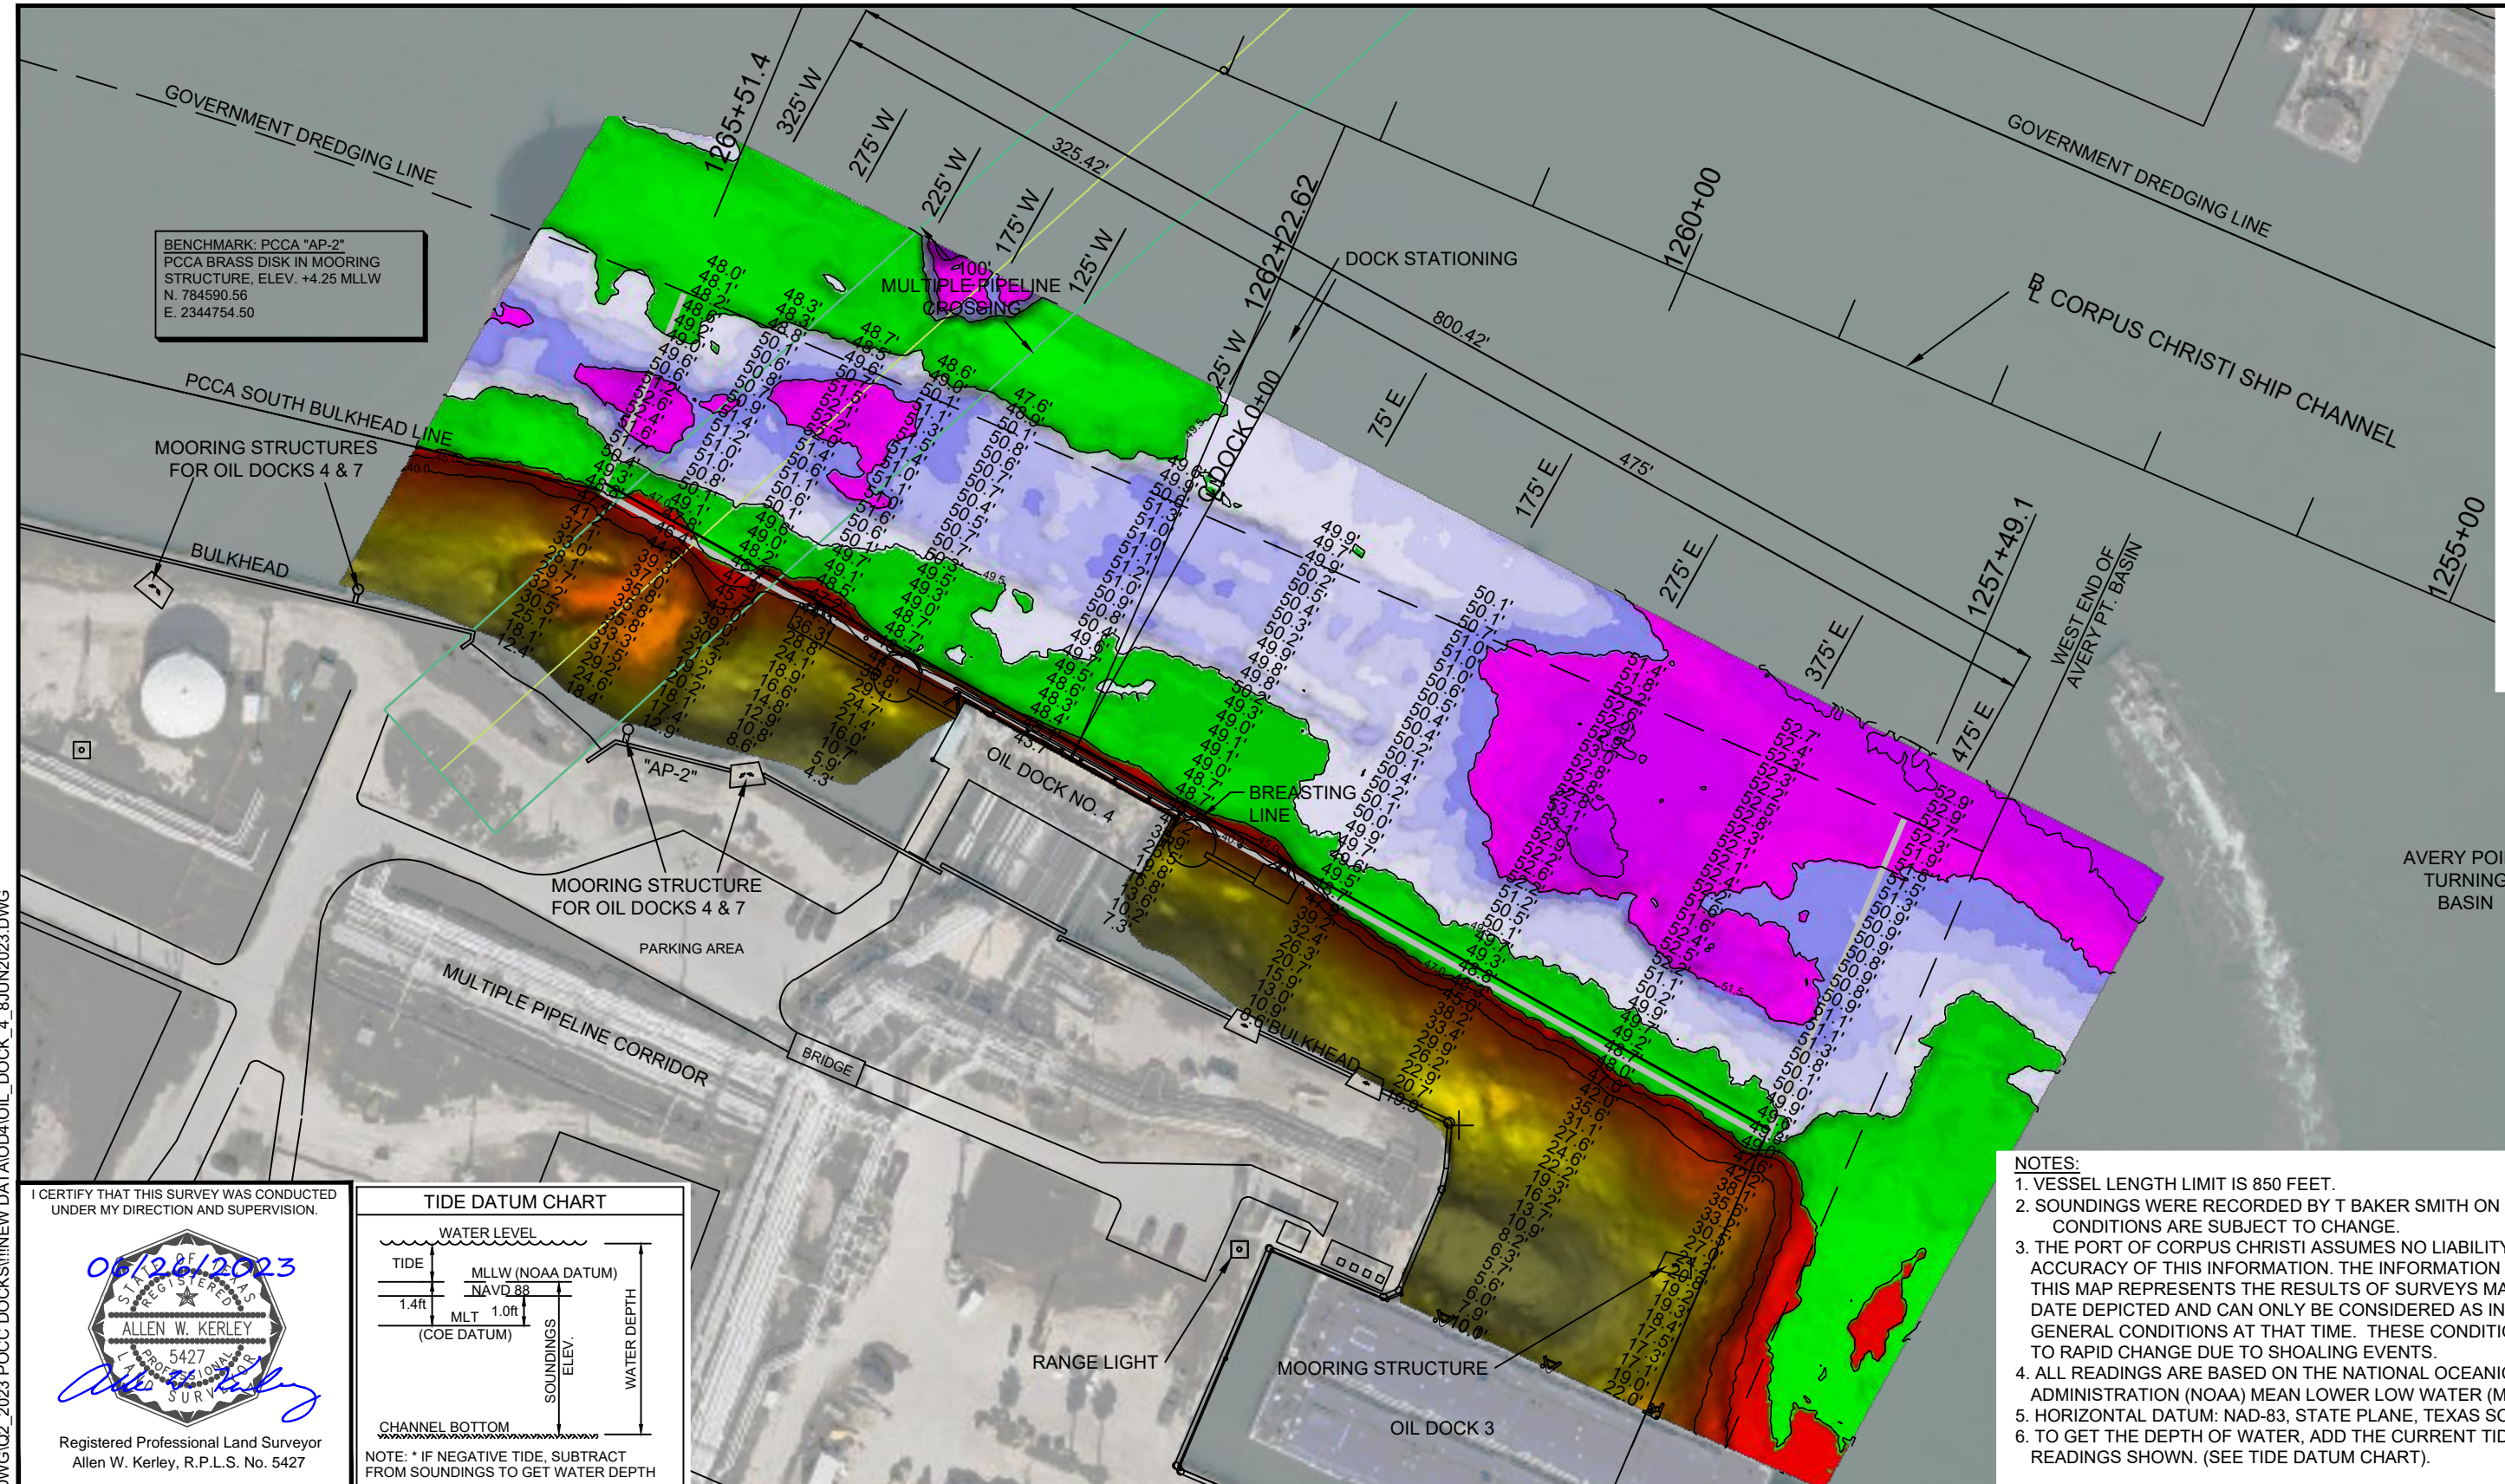
| SHEET NO: 1 | OF 1 |

BENCHMARK: PCCA "AP-2"
 PCCA BRASS DISK IN MOORING
 STRUCTURE, ELEV. +4.25 MLLW
 N. 784590.56
 E. 2344754.50
