PORT OF CORPUS CHRISTI AUTHORITY

**SOUNDINGS  
OIL DOCK 50**

DATE: NOV. 2022

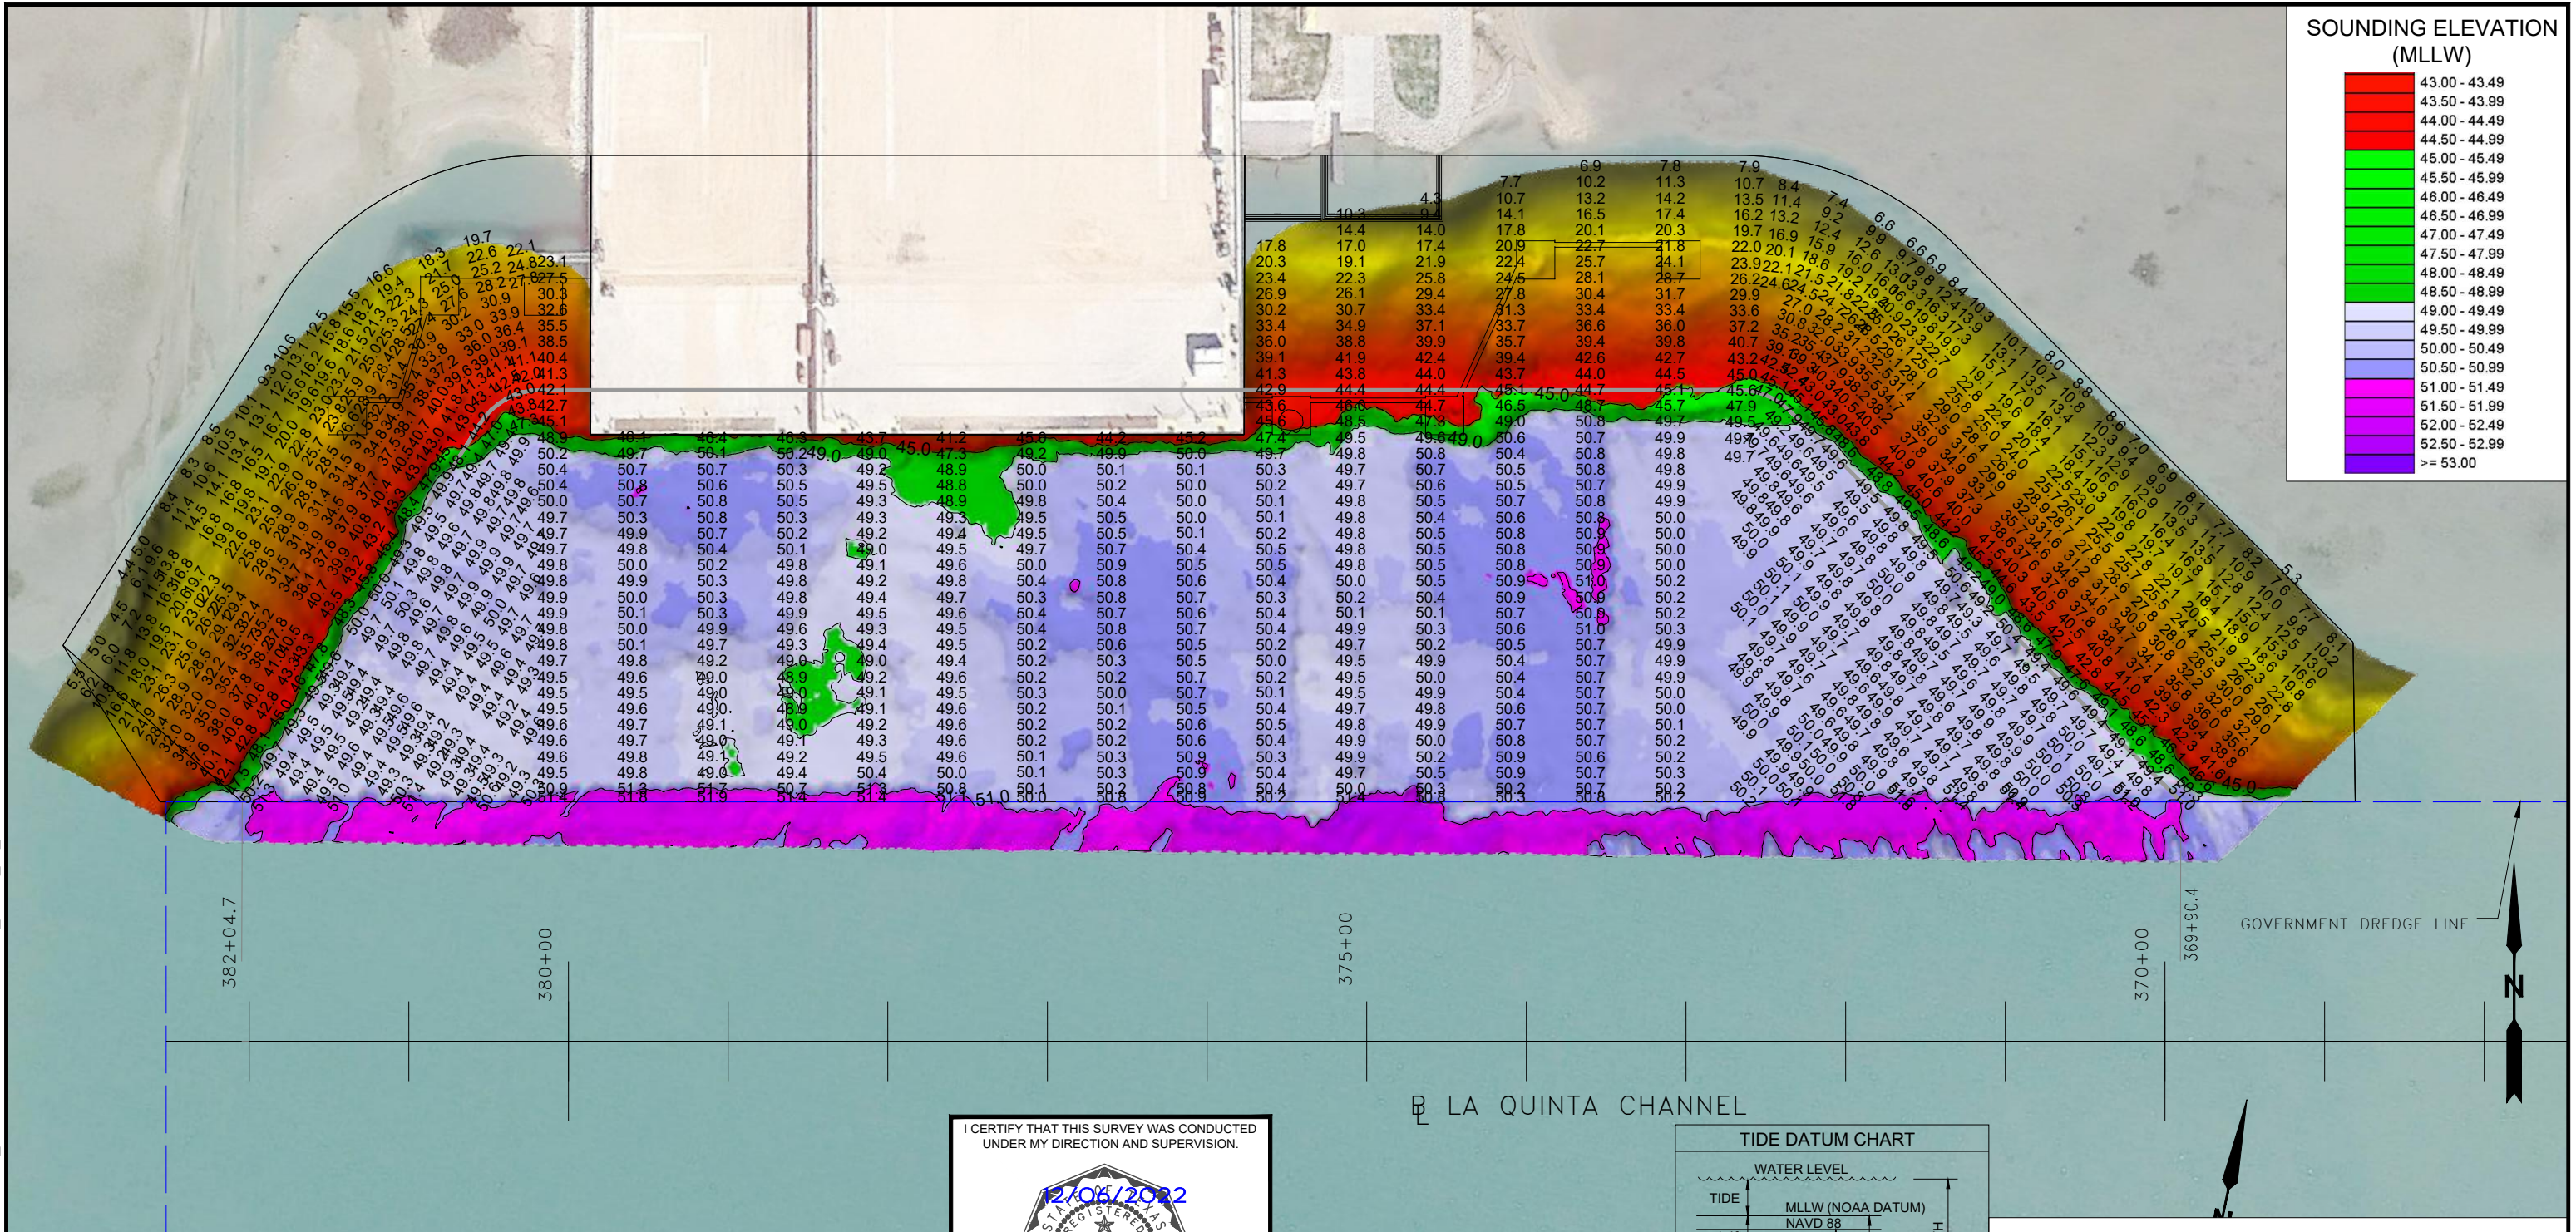
PLAN

- NOTES:**
- SOUNDINGS WERE RECORDED BY T BAKER SMITH ON 10 NOVEMBER, 2022. SEA FLOOR CONDITIONS ARE SUBJECT TO CHANGE.
  - THE PORT OF CORPUS CHRISTI ASSUMES NO LIABILITY FOR THE ACCURACY OF THIS INFORMATION. THE INFORMATION DEPICTED ON THIS MAP REPRESENTS THE RESULTS OF SURVEYS MADE ON THE DATE DEPICTED AND CAN ONLY BE CONSIDERED AS INDICATING THE GENERAL CONDITIONS AT THAT TIME. THESE CONDITIONS ARE SUBJECT TO RAPID CHANGE DUE TO SHOALING EVENTS.
  - ALL READINGS ARE BASED ON THE NATIONAL OCEANIC AND ATMOSPHERIC ADMINISTRATION (NOAA) MEAN LOWER LOW WATER (MLLW) DATUM, (O.O').
  - HORIZONTAL DATUM: NAD-83, STATE PLANE, TEXAS SOUTH ZONE, US FEET.
  - TO GET THE DEPTH OF WATER, ADD THE CURRENT TIDE LEVEL TO THE READINGS SHOWN. (SEE TIDE DATUM CHART).
