DRAWING NAME: OIL DOCK\_50\_13FEB2026

PORT OF CORPUS CHRISTI AUTHORITY

OIL DOCK 50  
SOUNDINGS  
AN EXHIBIT OF A  
BATHYMETRIC SURVEY  
LOCATED IN  
CORPUS CHRISTI, TEXAS

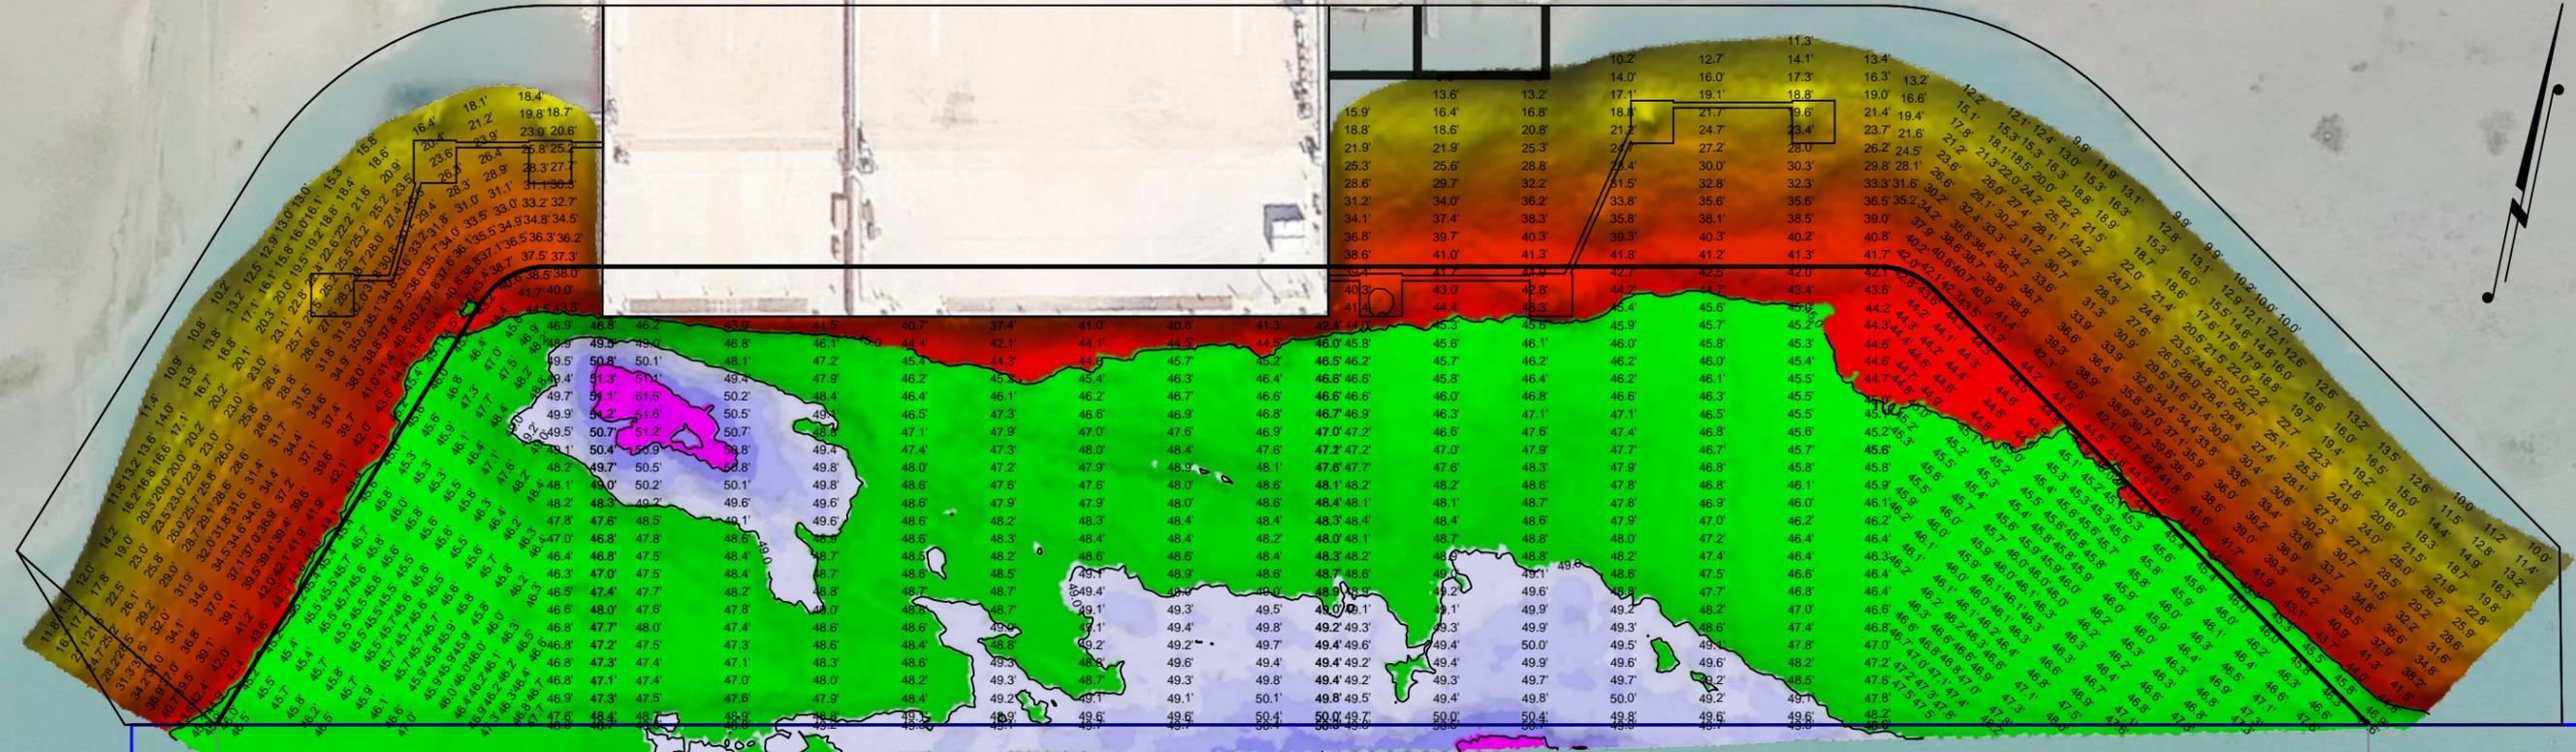
SHEET NO: 1 OF 1

GOVERNMENT DREDGE LINE

LA QUINTA CHANNEL

SOUNDINGS ELEVATION (MLLW)

- SOUNDINGS WERE RECORDED BY T BAKER SMITH ON 13 FEBRUARY, 2026. SEA FLOOR CONDITIONS ARE SUBJECT TO CHANGE.
- THE PORT OF CORPUS CHRISTI ASSUMES NO LIABILITY FOR THE ACCURACY OF THIS INFORMATION. THE INFORMATION DEPICTED ON THIS MAP REPRESENTS THE RESULTS OF SURVEYS MADE ON THE DATE DEPICTED AND CAN ONLY BE CONSIDERED AS INDICATING THE GENERAL CONDITIONS AT THAT TIME. THESE CONDITIONS ARE SUBJECT TO RAPID CHANGE DUE TO SHOALING EVENTS.
- ALL READINGS ARE BASED ON THE NATIONAL OCEANIC AND ATMOSPHERIC ADMINISTRATION (NOAA) MEAN LOWER LOW WATER (MLLW) DATUM, (O.O.)
- HORIZONTAL DATUM: NAD-83, STATE PLANE, TEXAS SOUTH ZONE, US FEET.
- TO GET THE DEPTH OF WATER, ADD THE CURRENT TIDE LEVEL TO THE READINGS SHOWN. (SEE TIDE DATUM CHART).
