PORT OF CORPUS CHRISTI AUTHORITY

OIL DOCK 50

SOUNDINGS

BATHYMETRIC SURVEY

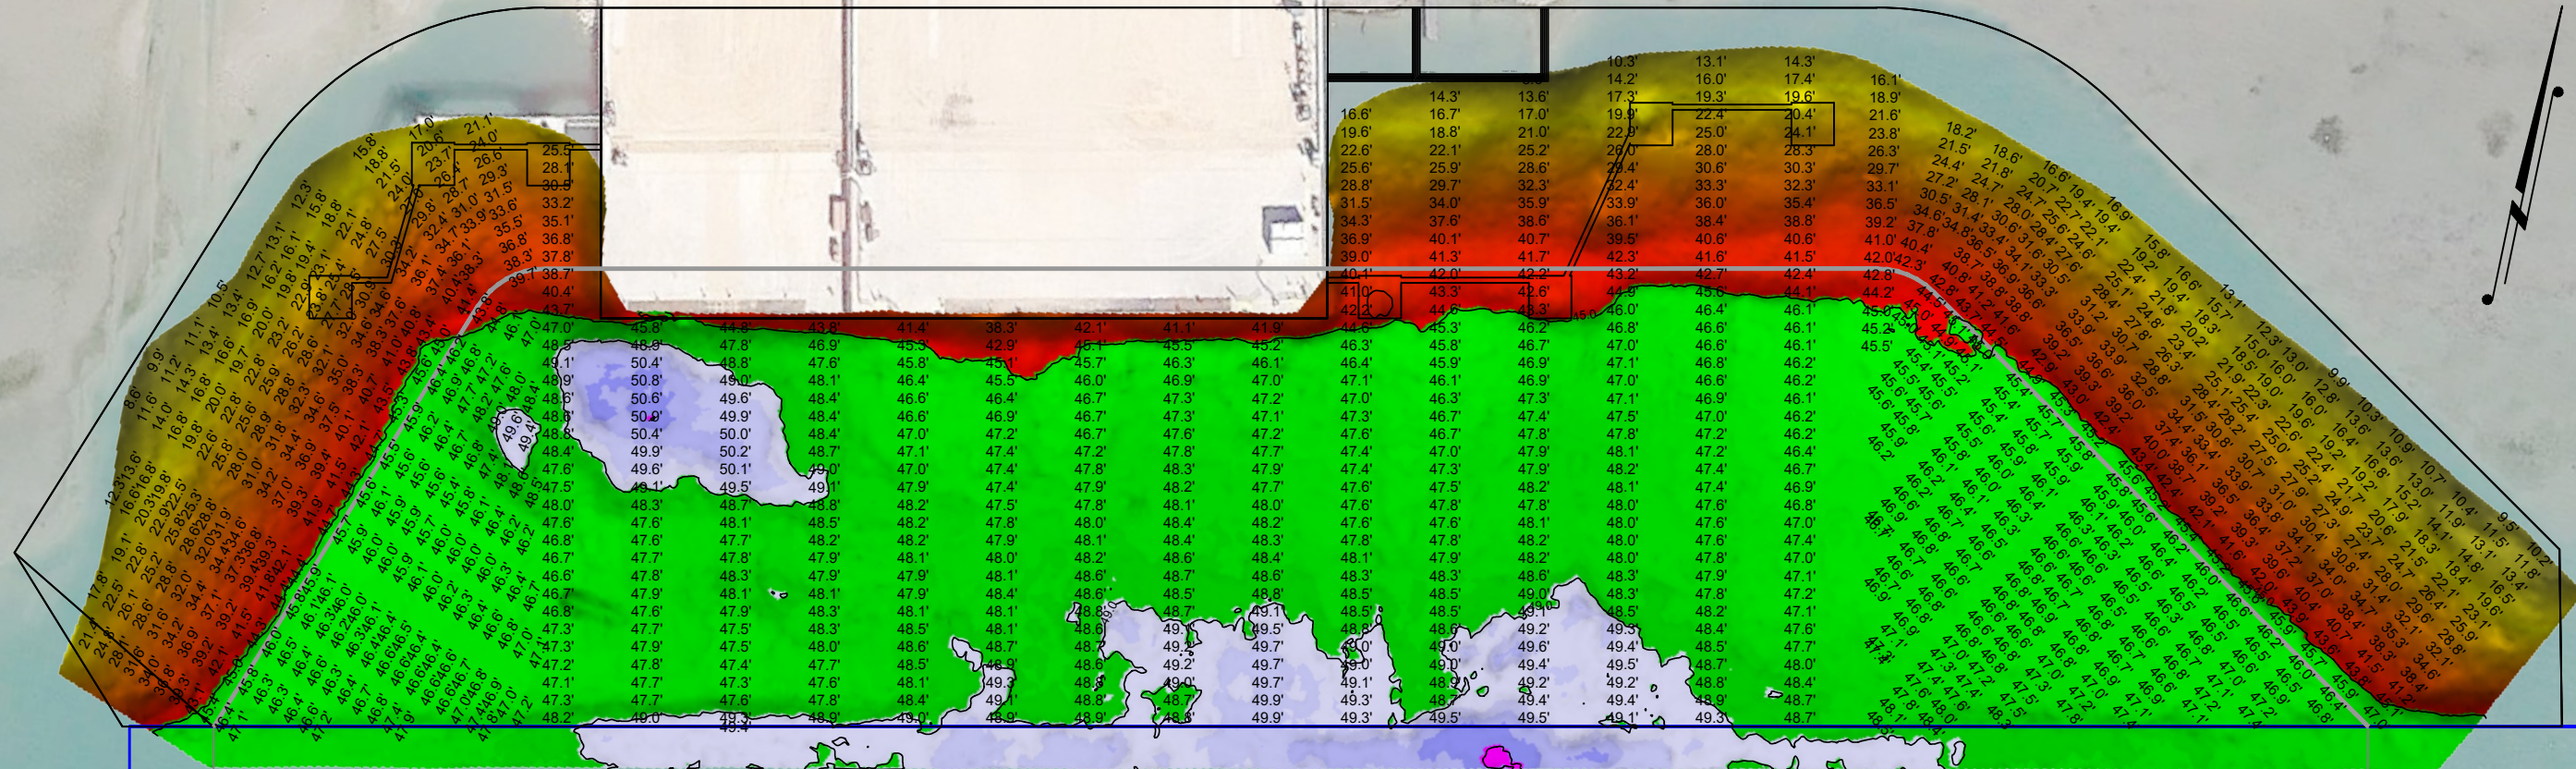
DRAWING NAME:
OIL_DOCK_50_17JUNE2025

- NOTES:
- SOUNDINGS WERE RECORDED BY T BAKER SMITH ON 17 JUNE, 2025.
 - SEA FLOOR CONDITIONS ARE SUBJECT TO CHANGE.
 - THE PORT OF CORPUS CHRISTI ASSUMES NO LIABILITY FOR THE ACCURACY OF THIS INFORMATION. THE INFORMATION DEPICTED ON THIS MAP REPRESENTS THE RESULTS OF SURVEYS MADE ON THE DATE DEPICTED AND CAN ONLY BE CONSIDERED AS INDICATING THE GENERAL CONDITIONS AT THAT TIME. THESE CONDITIONS ARE SUBJECT TO RAPID CHANGE DUE TO SHOALING EVENTS.
 - ALL READINGS ARE BASED ON THE NATIONAL OCEANIC AND ATMOSPHERIC ADMINISTRATION (NOAA) MEAN LOWER LOW WATER (MLLW) DATUM, (O.O')
 - HORIZONTAL DATUM: NAD-83, STATE PLANE, TEXAS SOUTH ZONE, US FEET.
 - TO GET THE DEPTH OF WATER, ADD THE CURRENT TIDE LEVEL TO THE READINGS SHOWN. (SEE TIDE DATUM CHART).
