<b>PORT CORPUS CHRISTI</b>	 <b>T. BAKER SMITH</b> A CENTURY OF SOLUTIONS 3854 FM 1069 Aransas Pass, TX 78336 (361)334-5719 - tbsmith.com TBPLS #10194575	 100' 50' 0' 100'	DRAWN BY: MMC	APPROVED BY: AWK	<b>PORT OF CORPUS CHRISTI AUTHORITY</b>  OIL DOCK 50 SOUNDINGS AN EXHIBIT OF A BATHYMETRIC SURVEY LOCATED IN CORPUS CHRISTI, TEXAS
			DATE: 11/29/2023	JOB NO: 2023.0091	
			DRAWING NAME: OIL DOCK 50 21NOV2023		
			PROJECTION: TEXAS STATE PLANE SOUTH ZONE GEO. DATUM: NAD83 (2011)   VERT. DATUM: NAVD88 GRID UNITS: US SURVEY FEET		
REVISION DESCRIPTION: --		SHEET NO: 1 OF 1

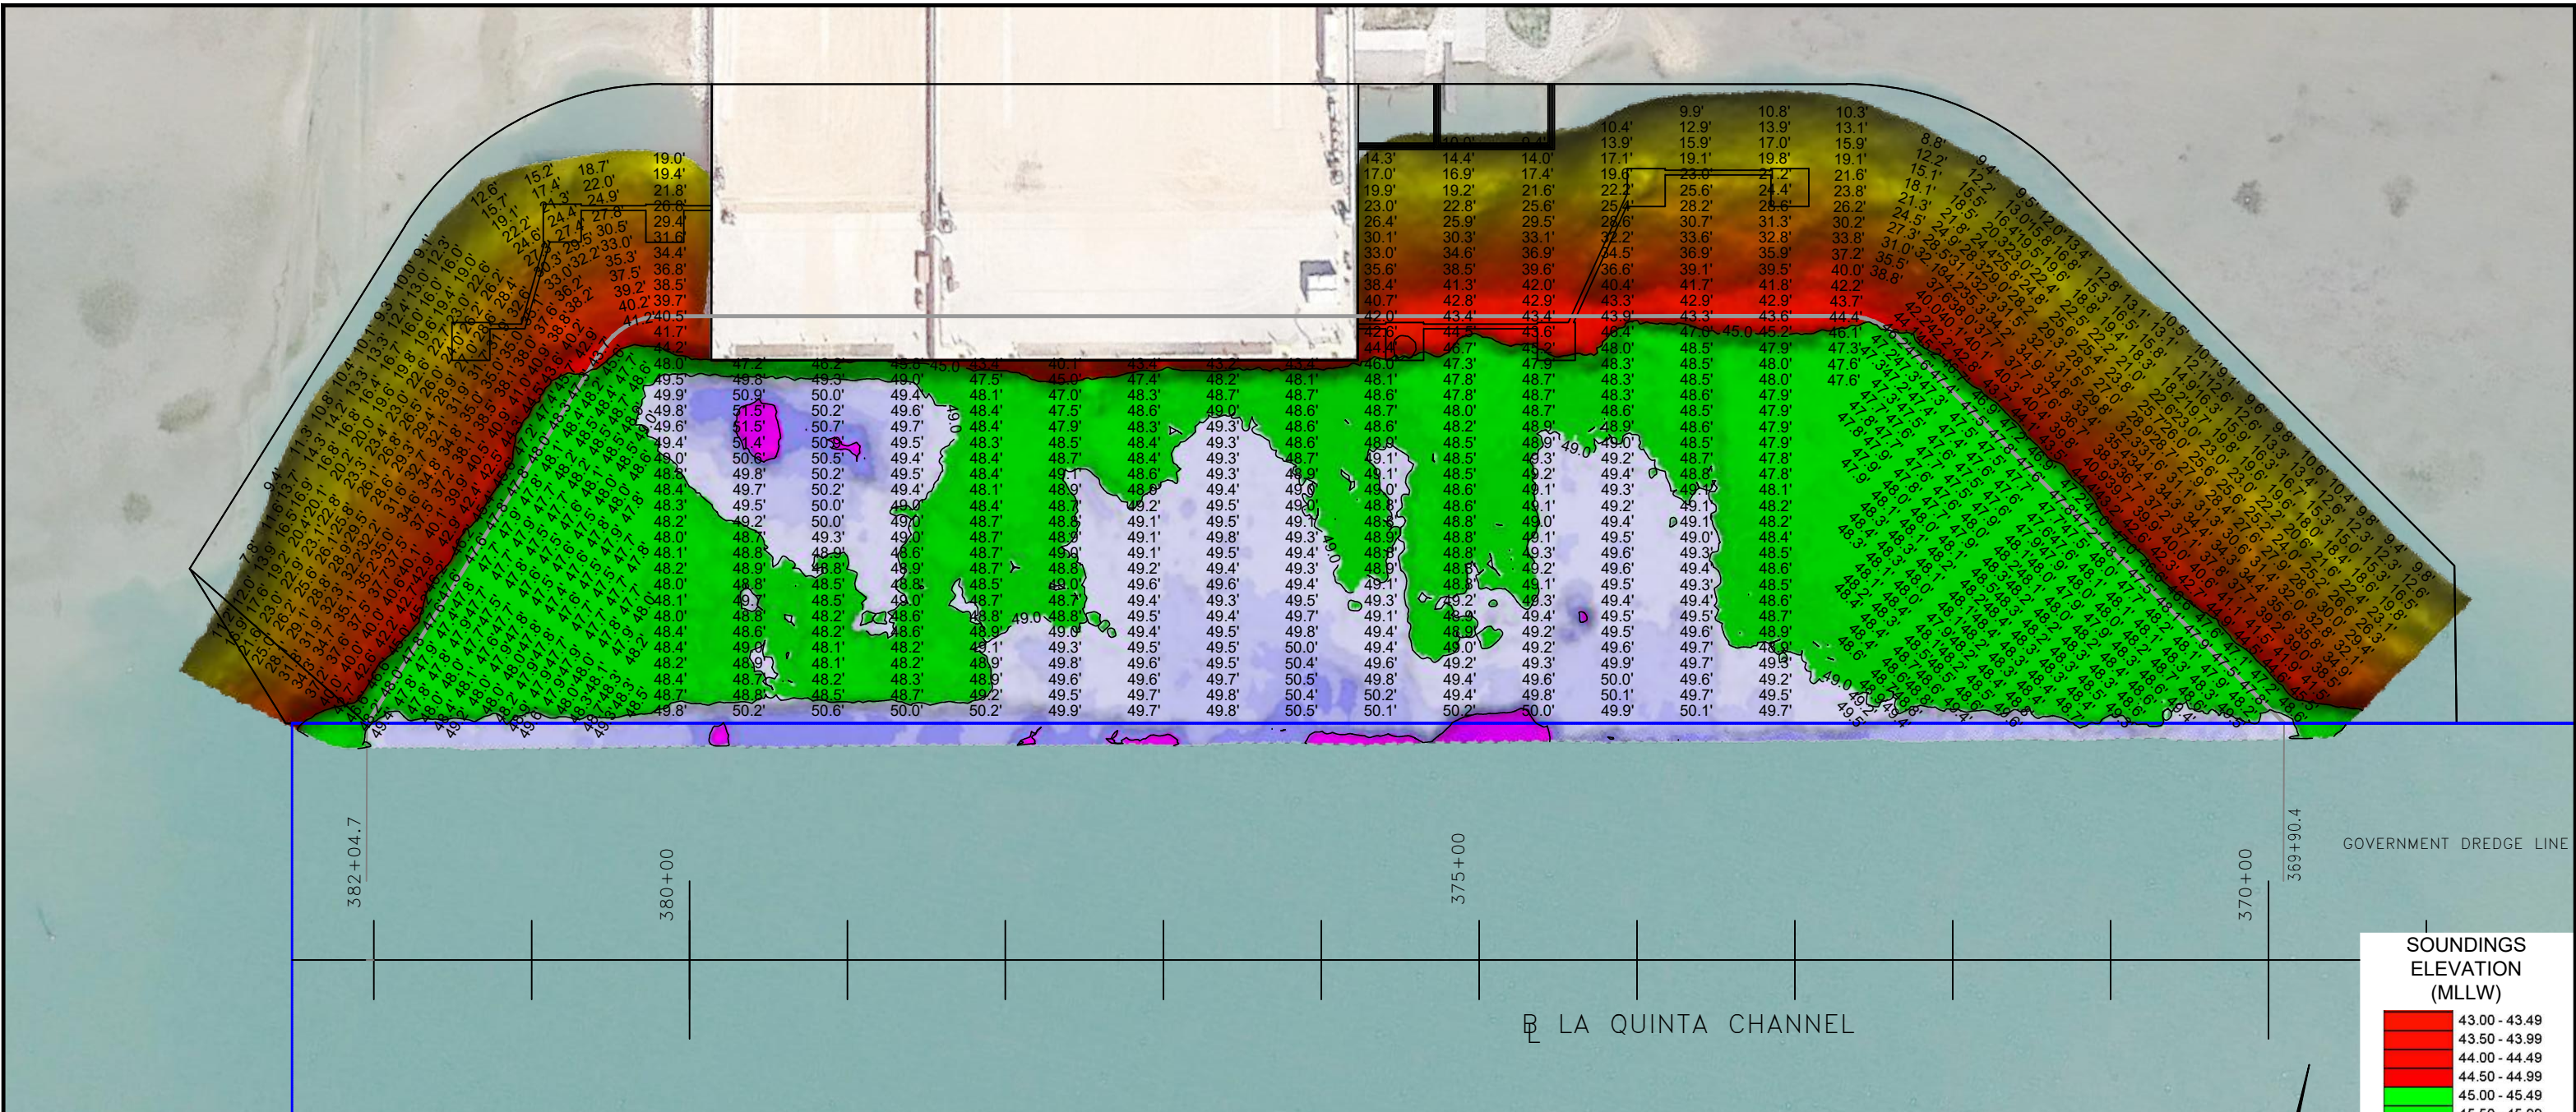
- NOTES:**
- SOUNDINGS WERE RECORDED BY T BAKER SMITH ON 21 NOVEMBER, 2023.
  - SEA FLOOR CONDITIONS ARE SUBJECT TO CHANGE.
  - THE PORT OF CORPUS CHRISTI ASSUMES NO LIABILITY FOR THE ACCURACY OF THIS INFORMATION. THE INFORMATION DEPICTED ON THIS MAP REPRESENTS THE RESULTS OF SURVEYS MADE ON THE DATE DEPICTED AND CAN ONLY BE CONSIDERED AS INDICATING THE GENERAL CONDITIONS AT THAT TIME. THESE CONDITIONS ARE SUBJECT TO RAPID CHANGE DUE TO SHOALING EVENTS.
  - ALL READINGS ARE BASED ON THE NATIONAL OCEANIC AND ATMOSPHERIC ADMINISTRATION (NOAA) MEAN LOWER LOW WATER (MLLW) DATUM, (O.O').
  - HORIZONTAL DATUM: NAD-83, STATE PLANE, TEXAS SOUTH ZONE, US FEET.
  - TO GET THE DEPTH OF WATER, ADD THE CURRENT TIDE LEVEL TO THE READINGS SHOWN. (SEE TIDE DATUM CHART).
