DRAWN BY:	MM	APPROVED BY:	AWK
DATE:	03/20/2023	JOB NO:	2023.0091
DRAWING NAME:	OIL_DOCK_50_22FEB2023		
PROJECTION:	TEXAS STATE PLANE SOUTH ZONE		
GEO. DATUM:	NAD83 (2011) VERT. DATUM: NAVD88		
GRID UNITS:	US SURVEY FEET		
SHEET NO:	1	OF	1

PORT OF CORPUS CHRISTI AUTHORITY
OIL DOCK 50
SOUNDINGS
AN EXHIBIT OF A
BATHYMETRIC SURVEY
LOCATED IN
CORPUS CHRISTI, TEXAS

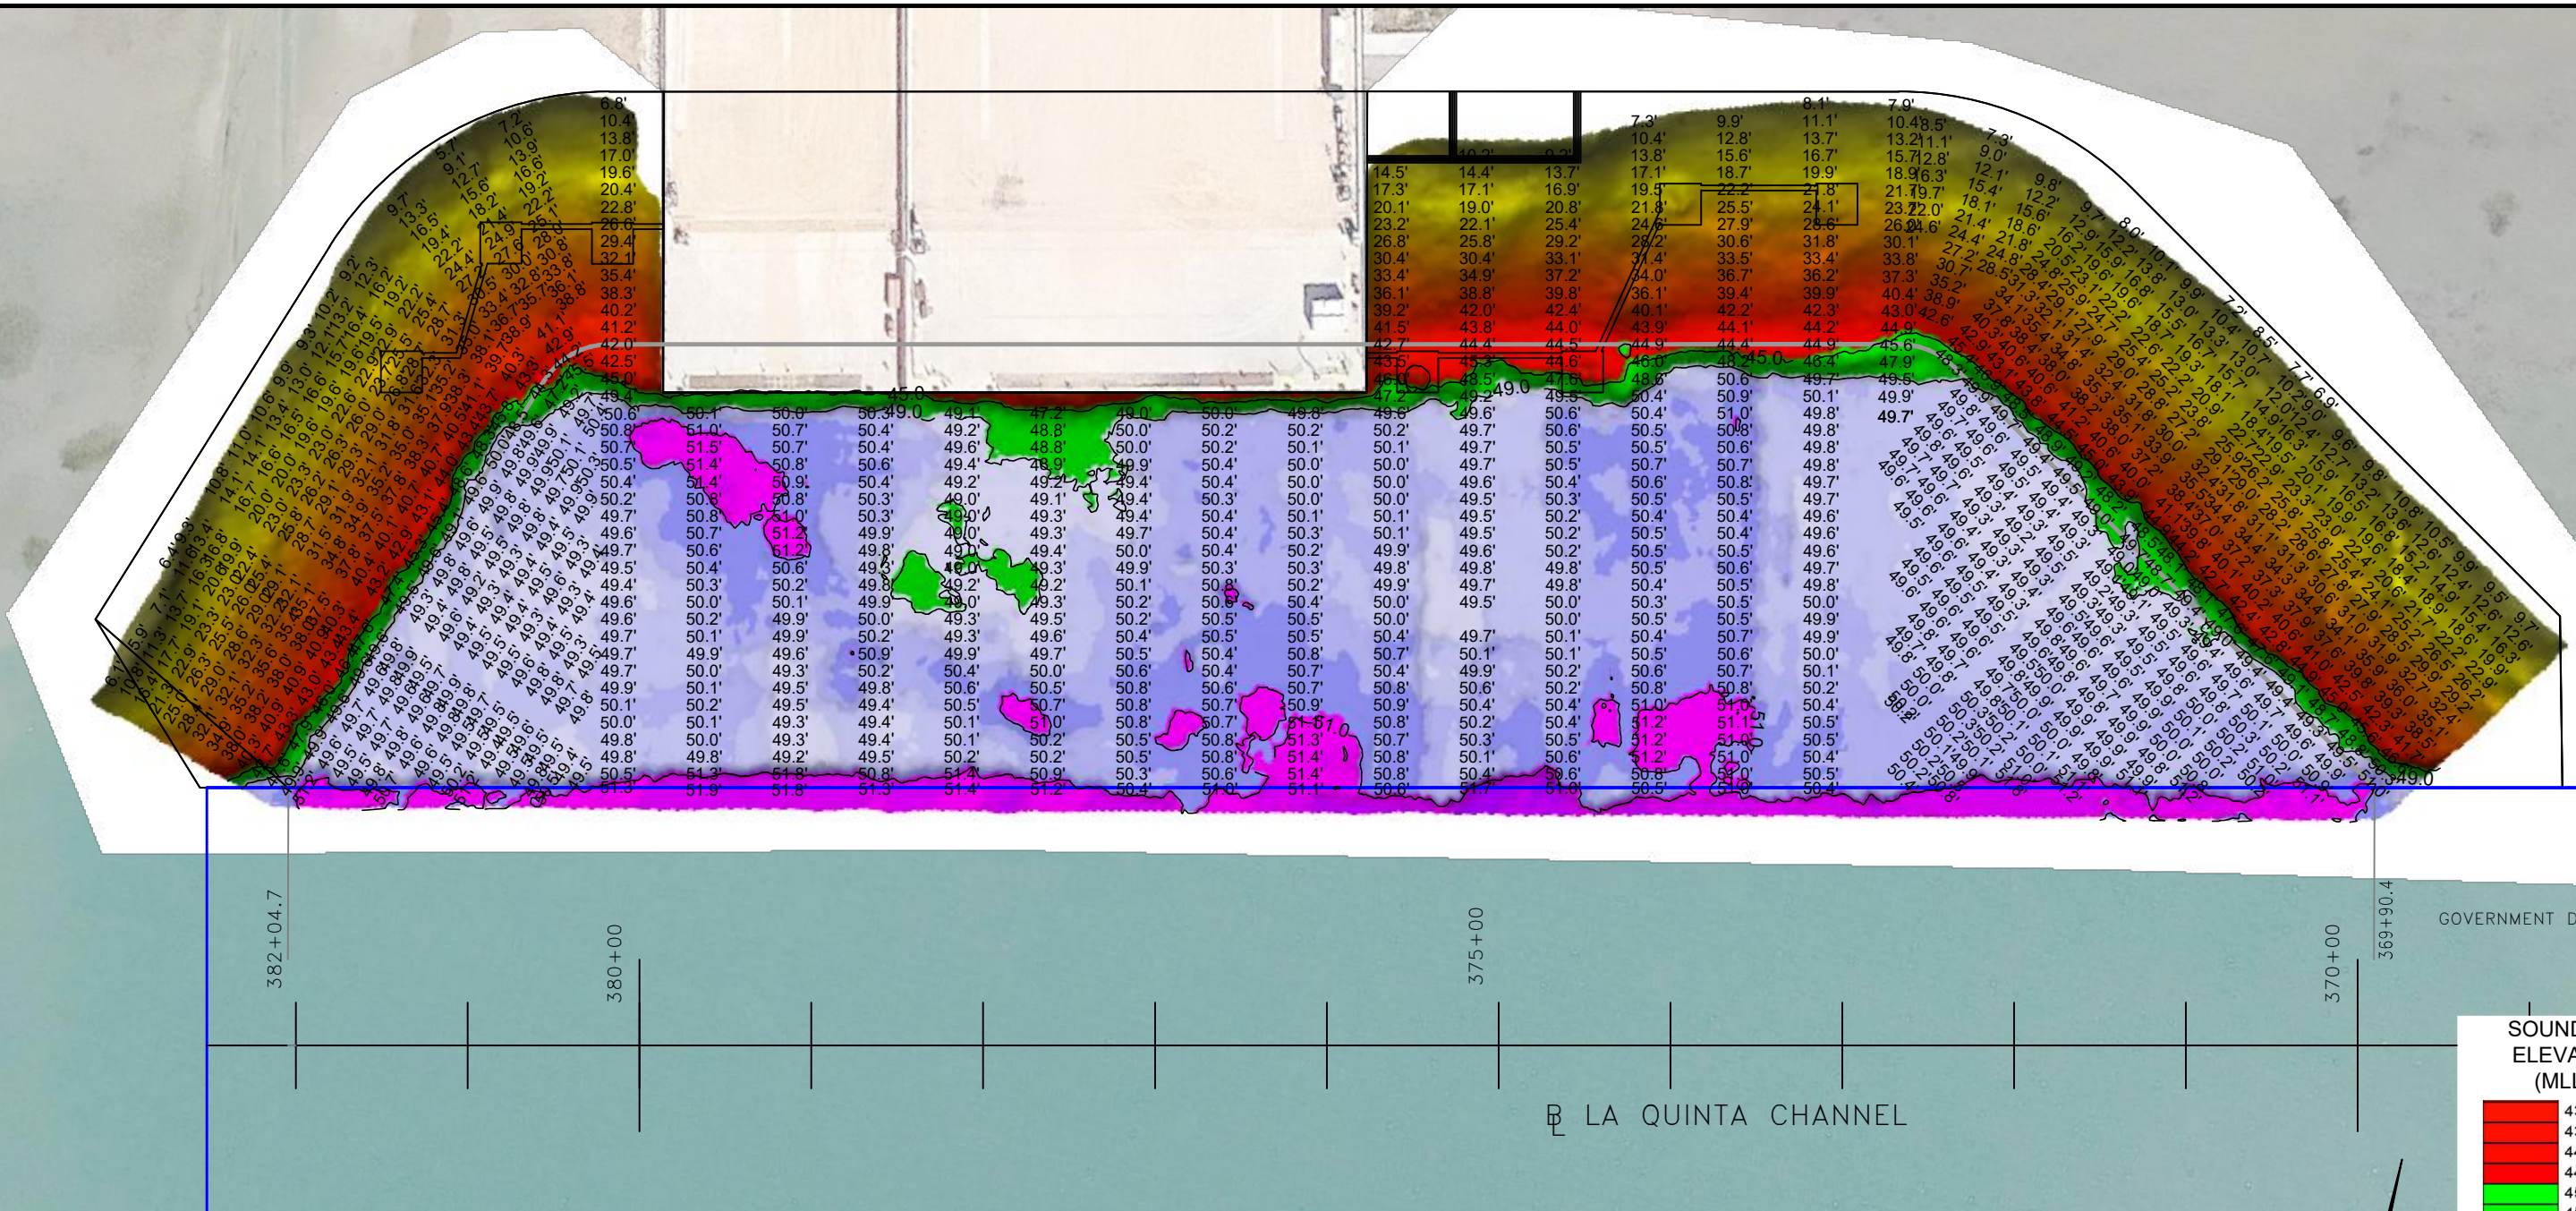
NOTES:
1. SOUNDINGS WERE RECORDED BY T BAKER SMITH ON 22 FEBRUARY, 2023.
SEA FLOOR CONDITIONS ARE SUBJECT TO CHANGE.
2. THE PORT OF CORPUS CHRISTI ASSUMES NO LIABILITY FOR THE ACCURACY OF THIS INFORMATION. THE INFORMATION DEPICTED ON THIS MAP REPRESENTS THE RESULTS OF SURVEYS MADE ON THE DATE DEPICTED AND CAN ONLY BE CONSIDERED AS INDICATING THE GENERAL CONDITIONS AT THAT TIME. THESE CONDITIONS ARE SUBJECT TO RAPID CHANGE DUE TO SHOALING EVENTS.
3. ALL READINGS ARE BASED ON THE NATIONAL OCEANIC AND ATMOSPHERIC ADMINISTRATION (NOAA) MEAN LOWER LOW WATER (MLLW) DATUM, (O.O.)
4. HORIZONTAL DATUM: NAD-83, STATE PLANE, TEXAS SOUTH ZONE, US FEET.
5. TO GET THE DEPTH OF WATER, ADD THE CURRENT TIDE LEVEL TO THE READINGS SHOWN. (SEE TIDE DATUM CHART).
