PORT OF CORPUS CHRISTI AUTHORITY

OIL DOCK 50
SOUNDINGS
AN EXHIBIT OF A
BATHYMETRIC SURVEY
LOCATED IN
CORPUS CHRISTI, TEXAS

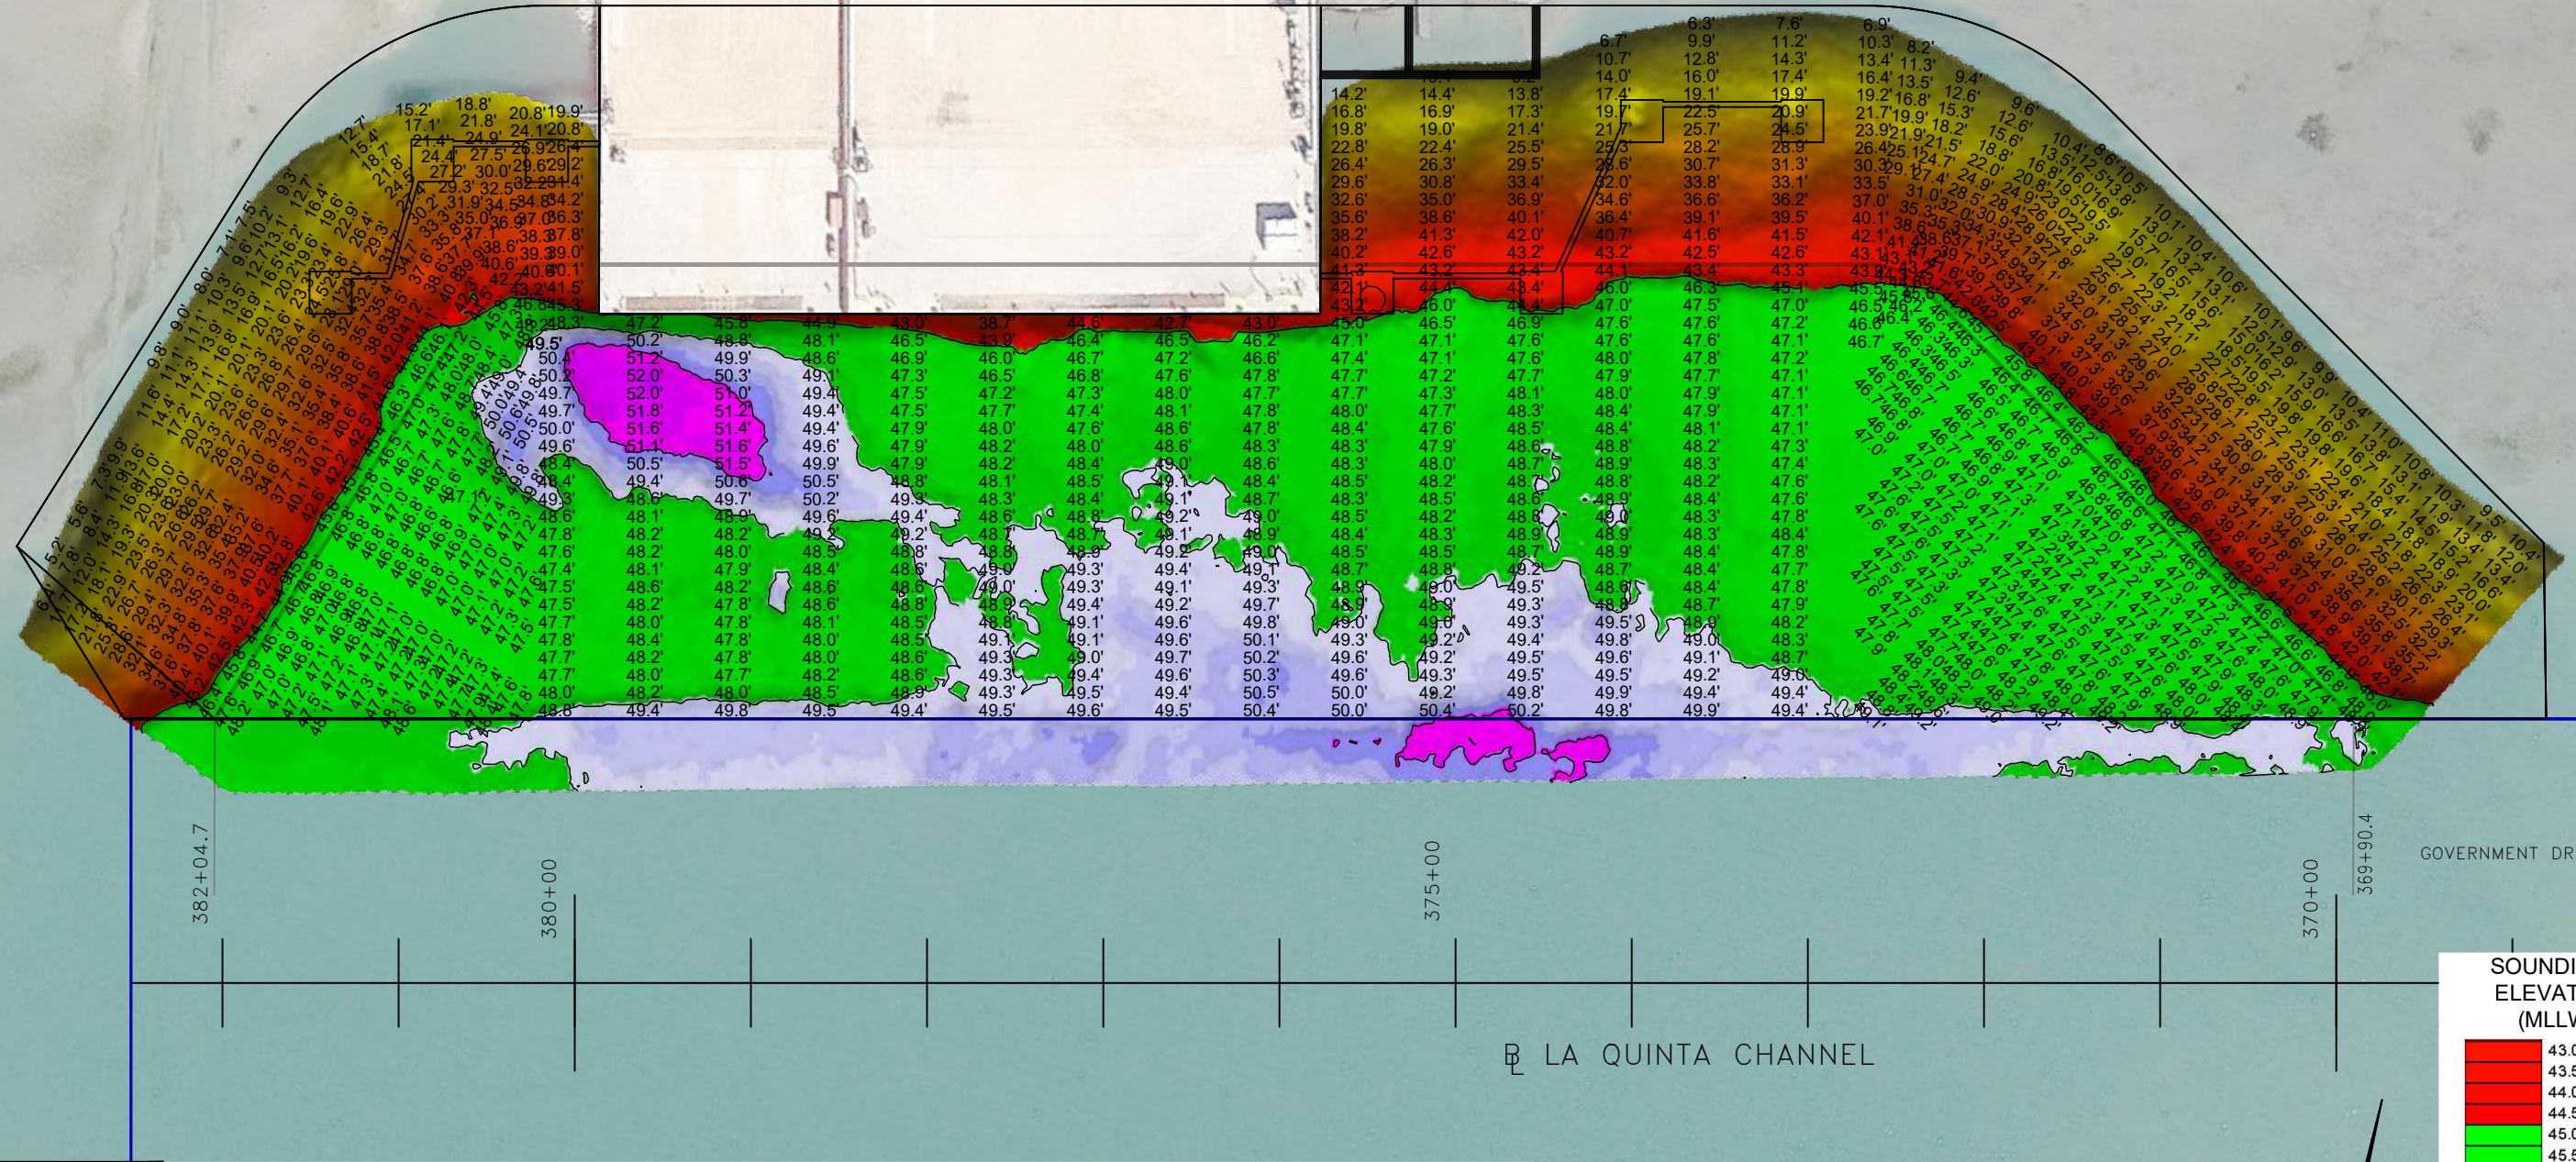
- NOTES:**
- SOUNDINGS WERE RECORDED BY T BAKER SMITH ON 20 DECEMBER, 2024. SEA FLOOR CONDITIONS ARE SUBJECT TO CHANGE.
 - THE PORT OF CORPUS CHRISTI ASSUMES NO LIABILITY FOR THE ACCURACY OF THIS INFORMATION. THE INFORMATION DEPICTED ON THIS MAP REPRESENTS THE RESULTS OF SURVEYS MADE ON THE DATE DEPICTED AND CAN ONLY BE CONSIDERED AS INDICATING THE GENERAL CONDITIONS AT THAT TIME. THESE CONDITIONS ARE SUBJECT TO RAPID CHANGE DUE TO SHOALING EVENTS.
 - ALL READINGS ARE BASED ON THE NATIONAL OCEANIC AND ATMOSPHERIC ADMINISTRATION (NOAA) MEAN LOWER LOW WATER (MLLW) DATUM, (O.O.)
 - HORIZONTAL DATUM: NAD-83, STATE PLANE, TEXAS SOUTH ZONE, US FEET.
 - TO GET THE DEPTH OF WATER, ADD THE CURRENT TIDE LEVEL TO THE READINGS SHOWN. (SEE TIDE DATUM CHART).
