**Project Turnpike  
Water and Sediment Sampling and Analysis Report**

**Wood Project No. 6703180051**

**Port of Corpus Christi Authority  
222 Power Street  
Corpus Christi, Texas 78401**

**June 2019**

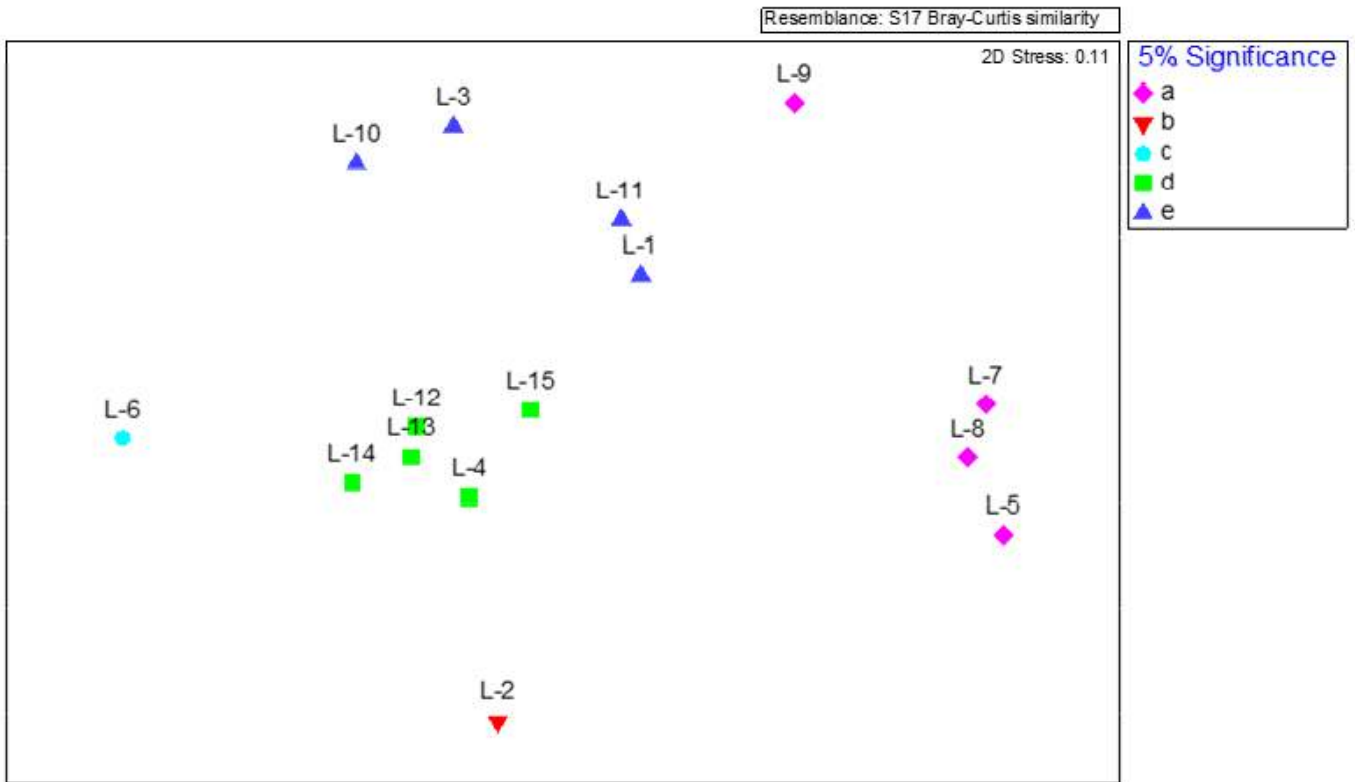
PCCA Harbor Island Permit Application  
Two-Dimensional nMDS

Two-dimensional nMDS plot of benthic macroinvertebrate samples with the 5% significance level as a factor.

Additionally, Bray-Curtis similarities were ordinated with non-metric Multidimensional Scaling (nMDS). The 5% significance level was used as a factor in the nMDS to further illustrate the significant relationships between the sample groups in 2-D space (**Figure 9**). The closer the sample points were to each other the more similar their benthic community structure. Similar sample grouping was observed in the nMDS as compared to the CLUSTER dendrogram. Analysis of Similarity (ANOSIM) confirmed statistically significant differences between the five sample groups represented in the CLUSTER dendrogram and the nMDS plot ( $p < 0.05$ ).

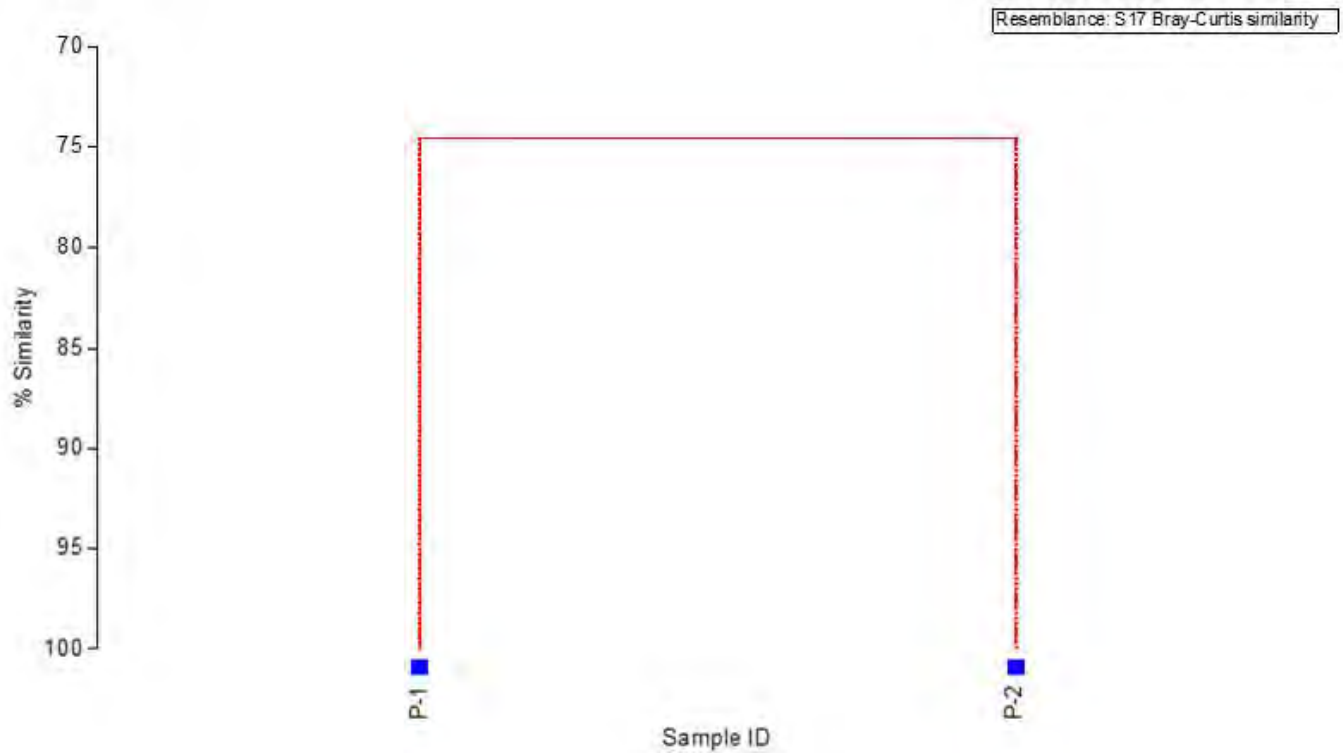
PCCA Harbor Island Permit Application  
 Dendrogram Results from the CLUSTER Analysis  
 with the SIMPROF Option of the Plankton Samples

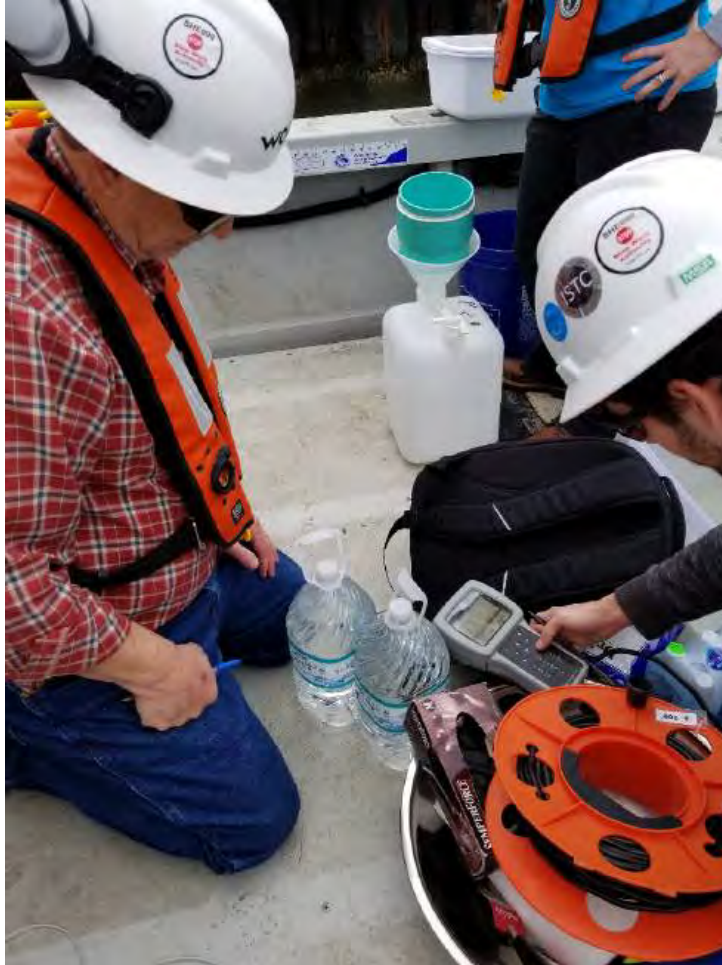
**PHOTO 1:**

Wood personnel  
calibrating water quality  
meter.

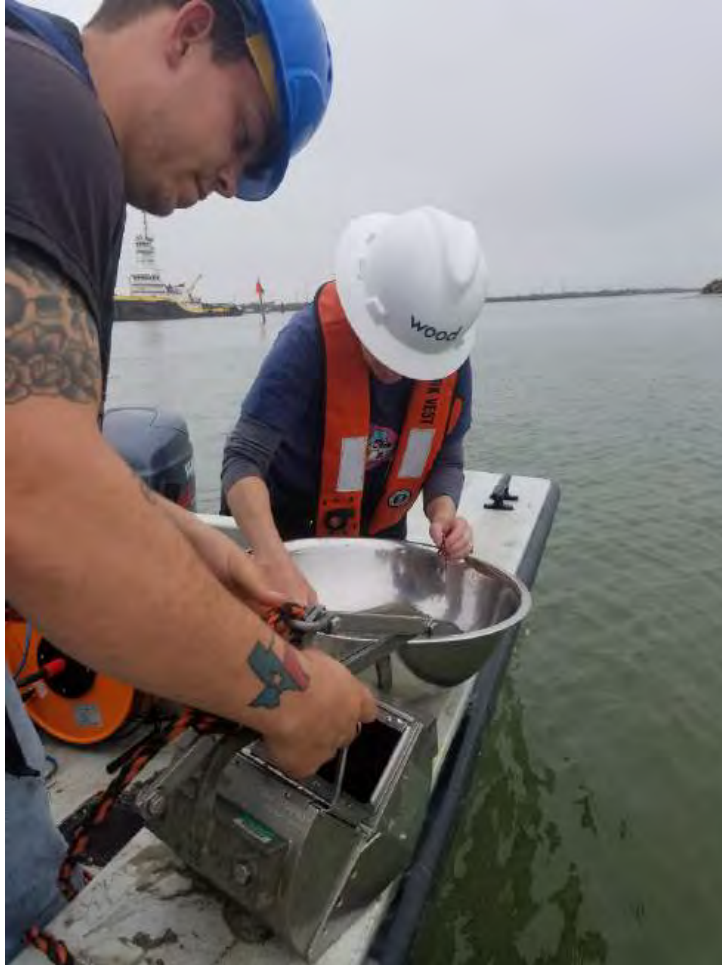
**PHOTO 3:**

Naismith personnel prepare petite ponar for deployment. Wood personnel investigates ponar grab for evidence of seagrass.

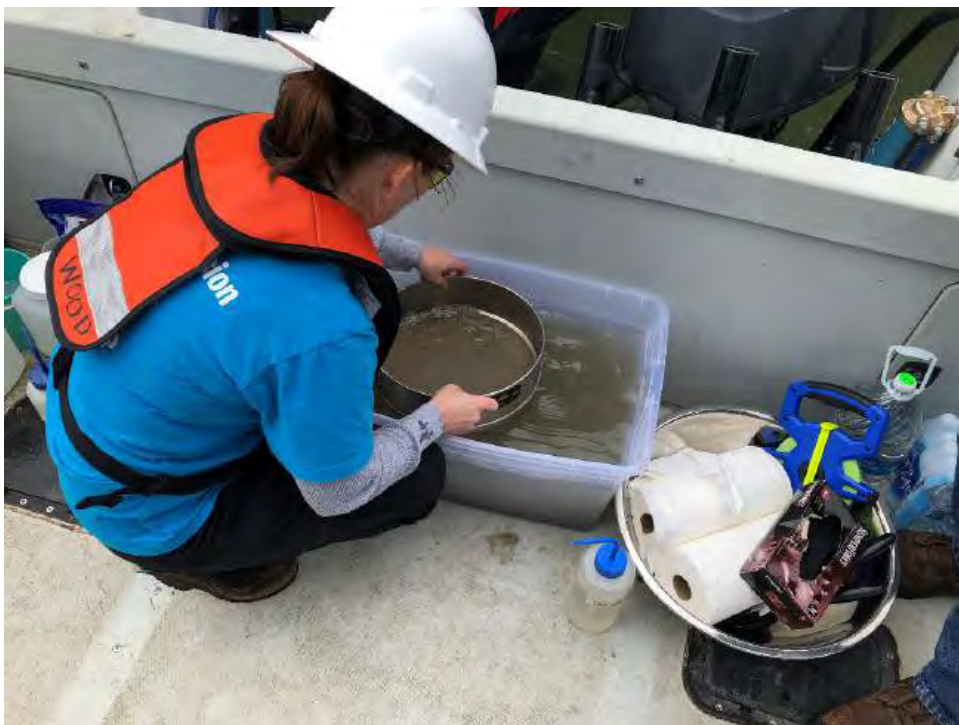
**PHOTO 4:**

Wood personnel sieve material collected by a petite ponar grab for benthic invertebrates.

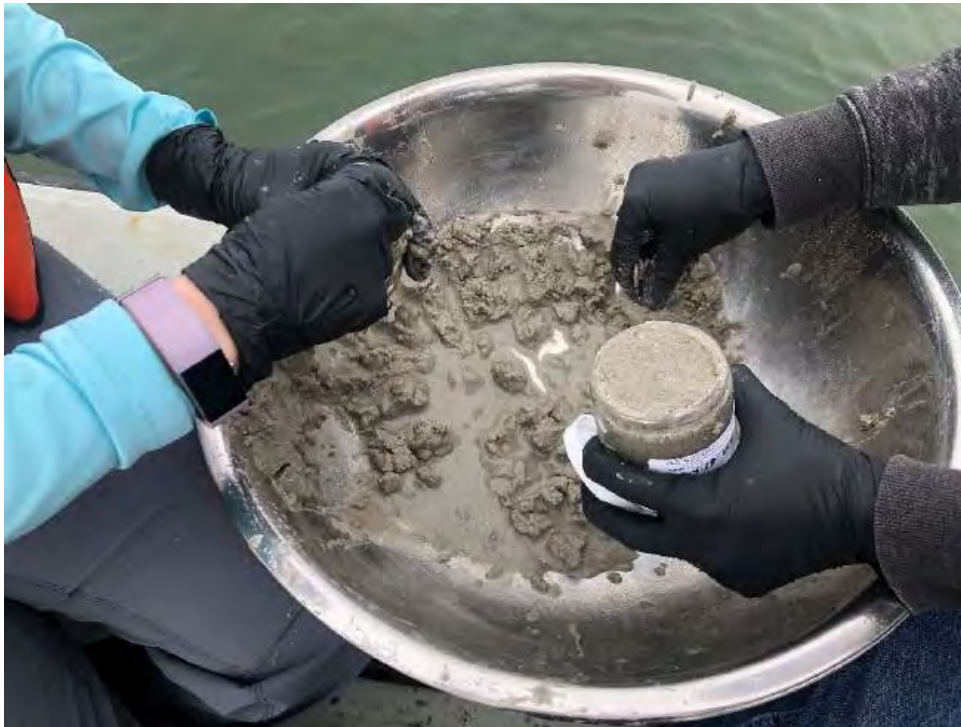
**PHOTO 7:**

Placing sediment collected using petite ponar into sample containers for laboratory testing.

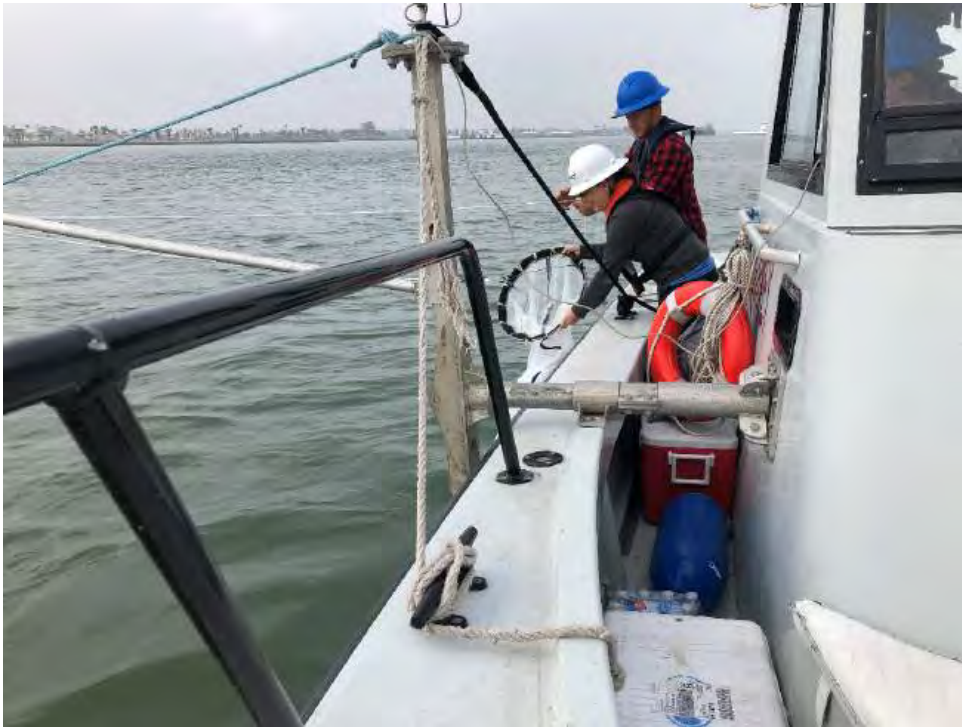
**PHOTO 11:**

Wood and Naismith  
personnel deploy  
plankton net.

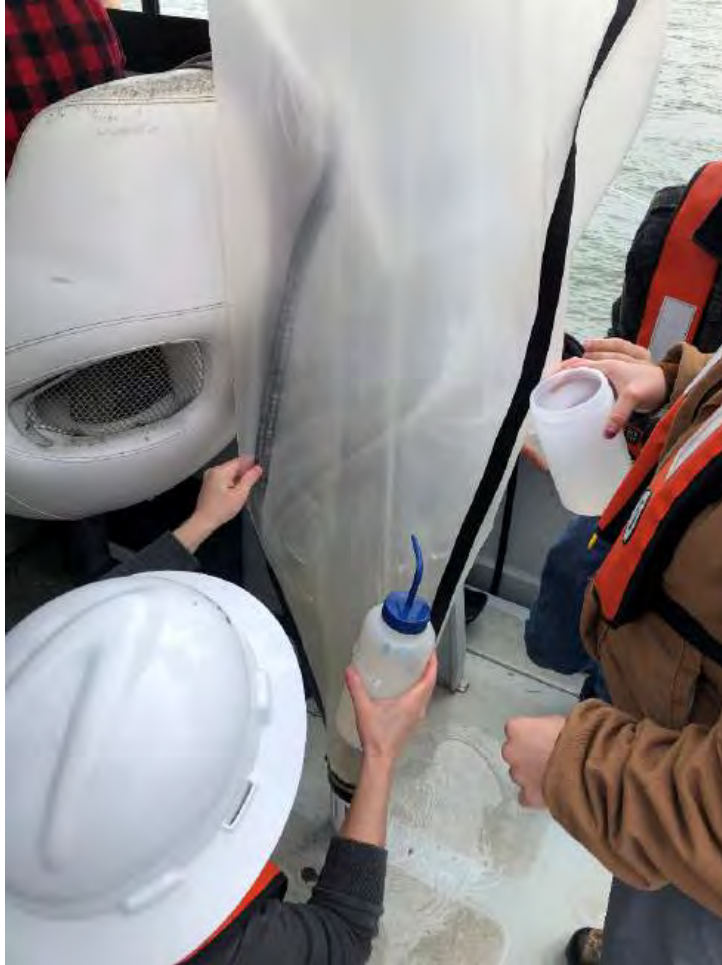
**PHOTO 15:**

Wood personnel rinsing the net to get all organisms down to the sample collection container at the cod end.

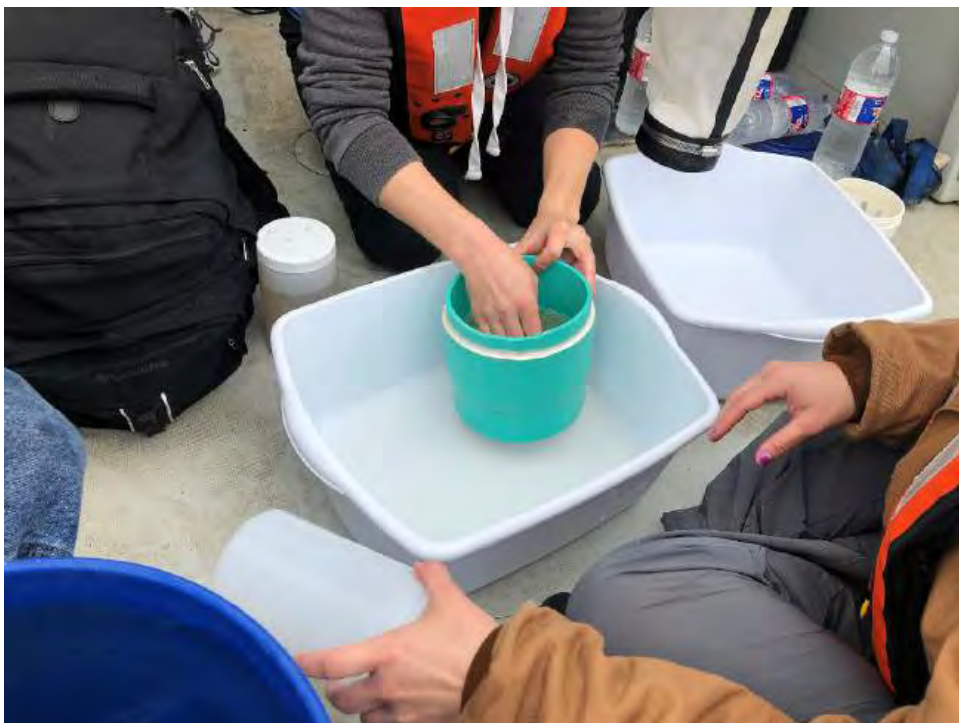
**PHOTO 16:**

Wood personnel use a fine mesh sieve to concentrate plankton samples prior to transferring to sample containers.

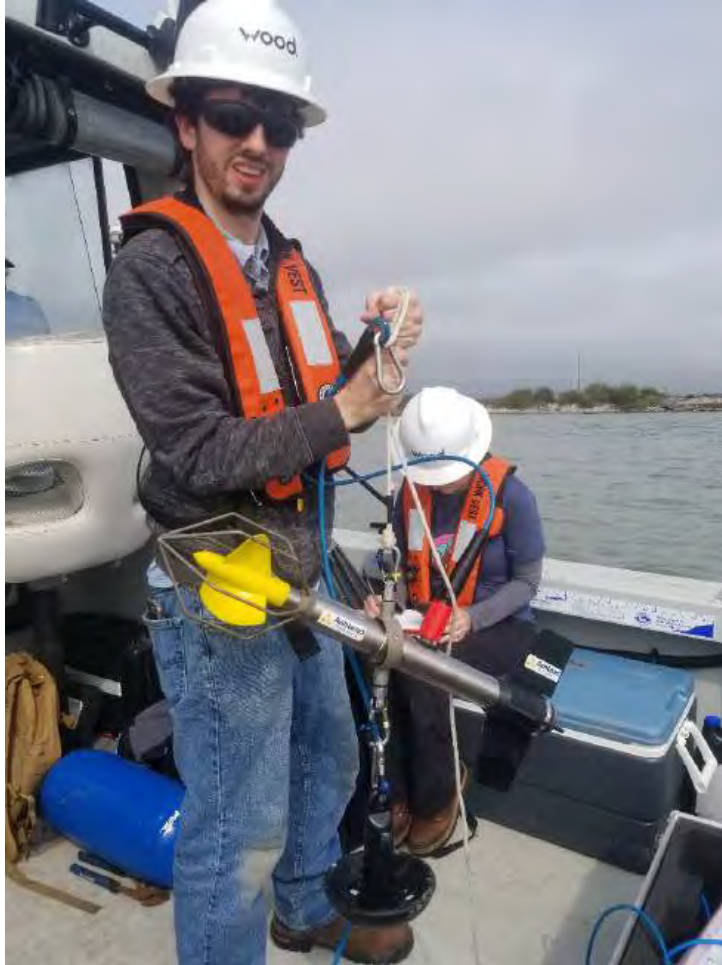
**PHOTO 19:**

Wood supporting the  
Valeport 106 Water  
Velocity Meter.

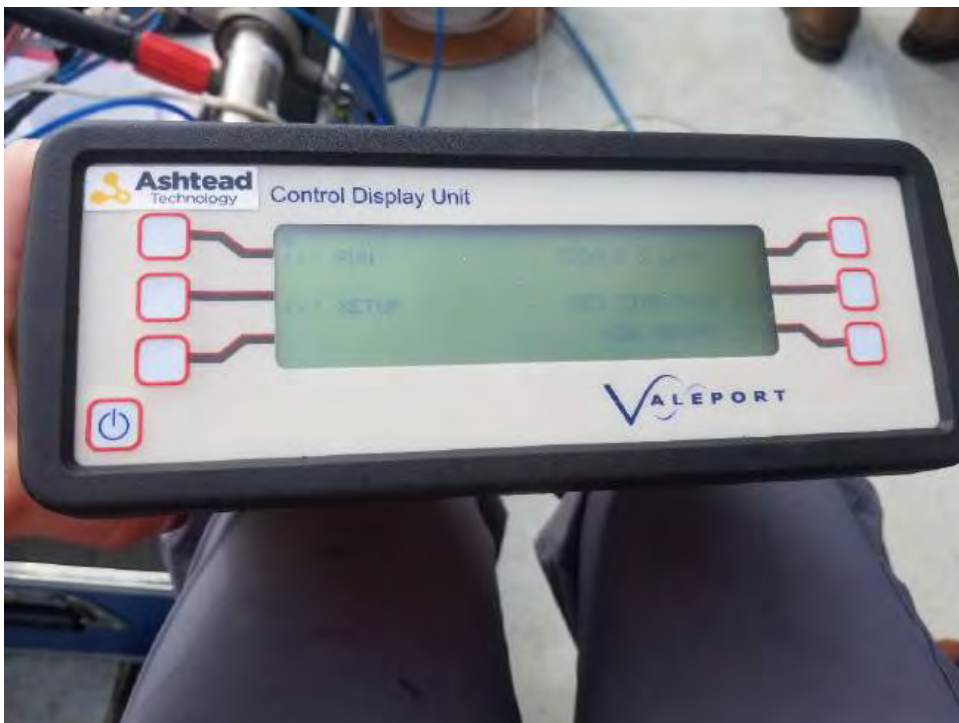
**PHOTO 20:**

Valeport 106 Water  
Velocity Meter display  
screen.

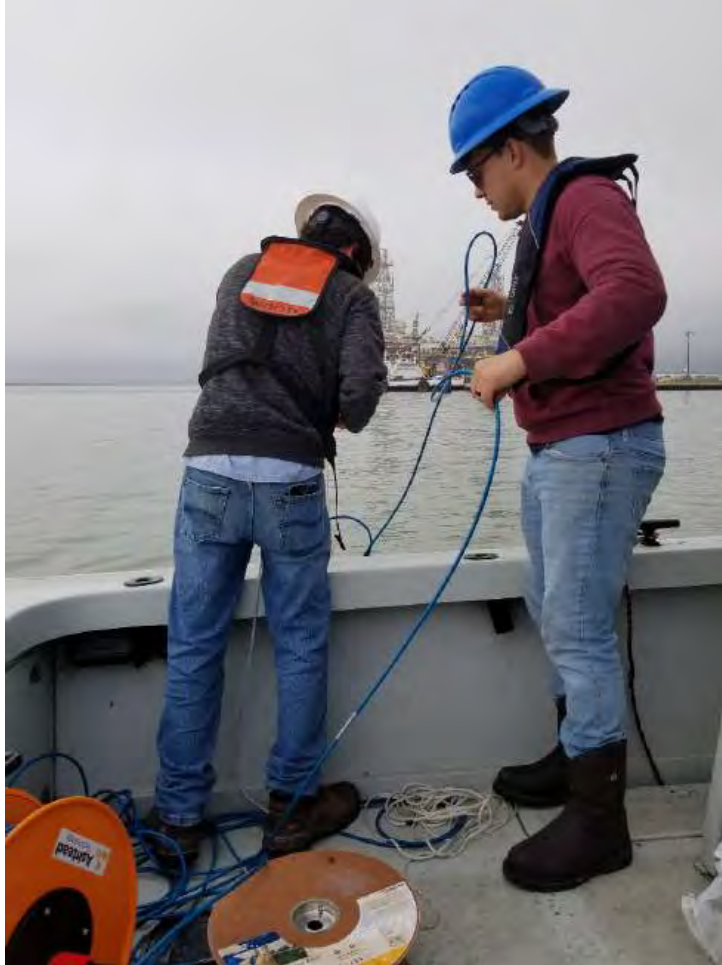
**PHOTO 22:**

Wood and Naismith  
personnel deploying  
the Valeport 106 Water  
Velocity Meter.
